River Bush Habitat Restoration Project

Dr. Gareth Greer

Conservation Officer, Rivers Agency

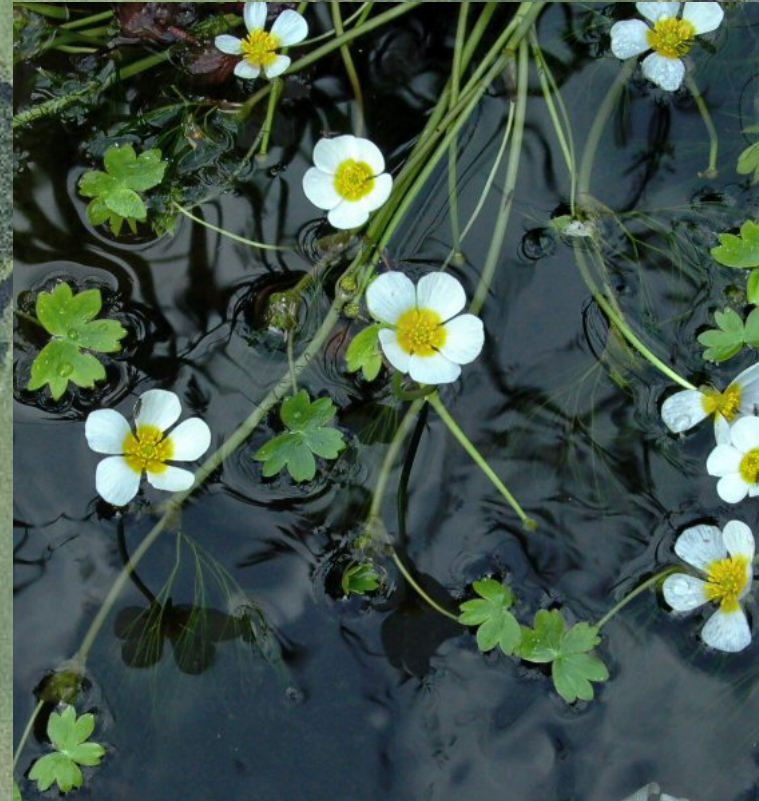
- Habitat modification
- Introduction of *Ranunculus*

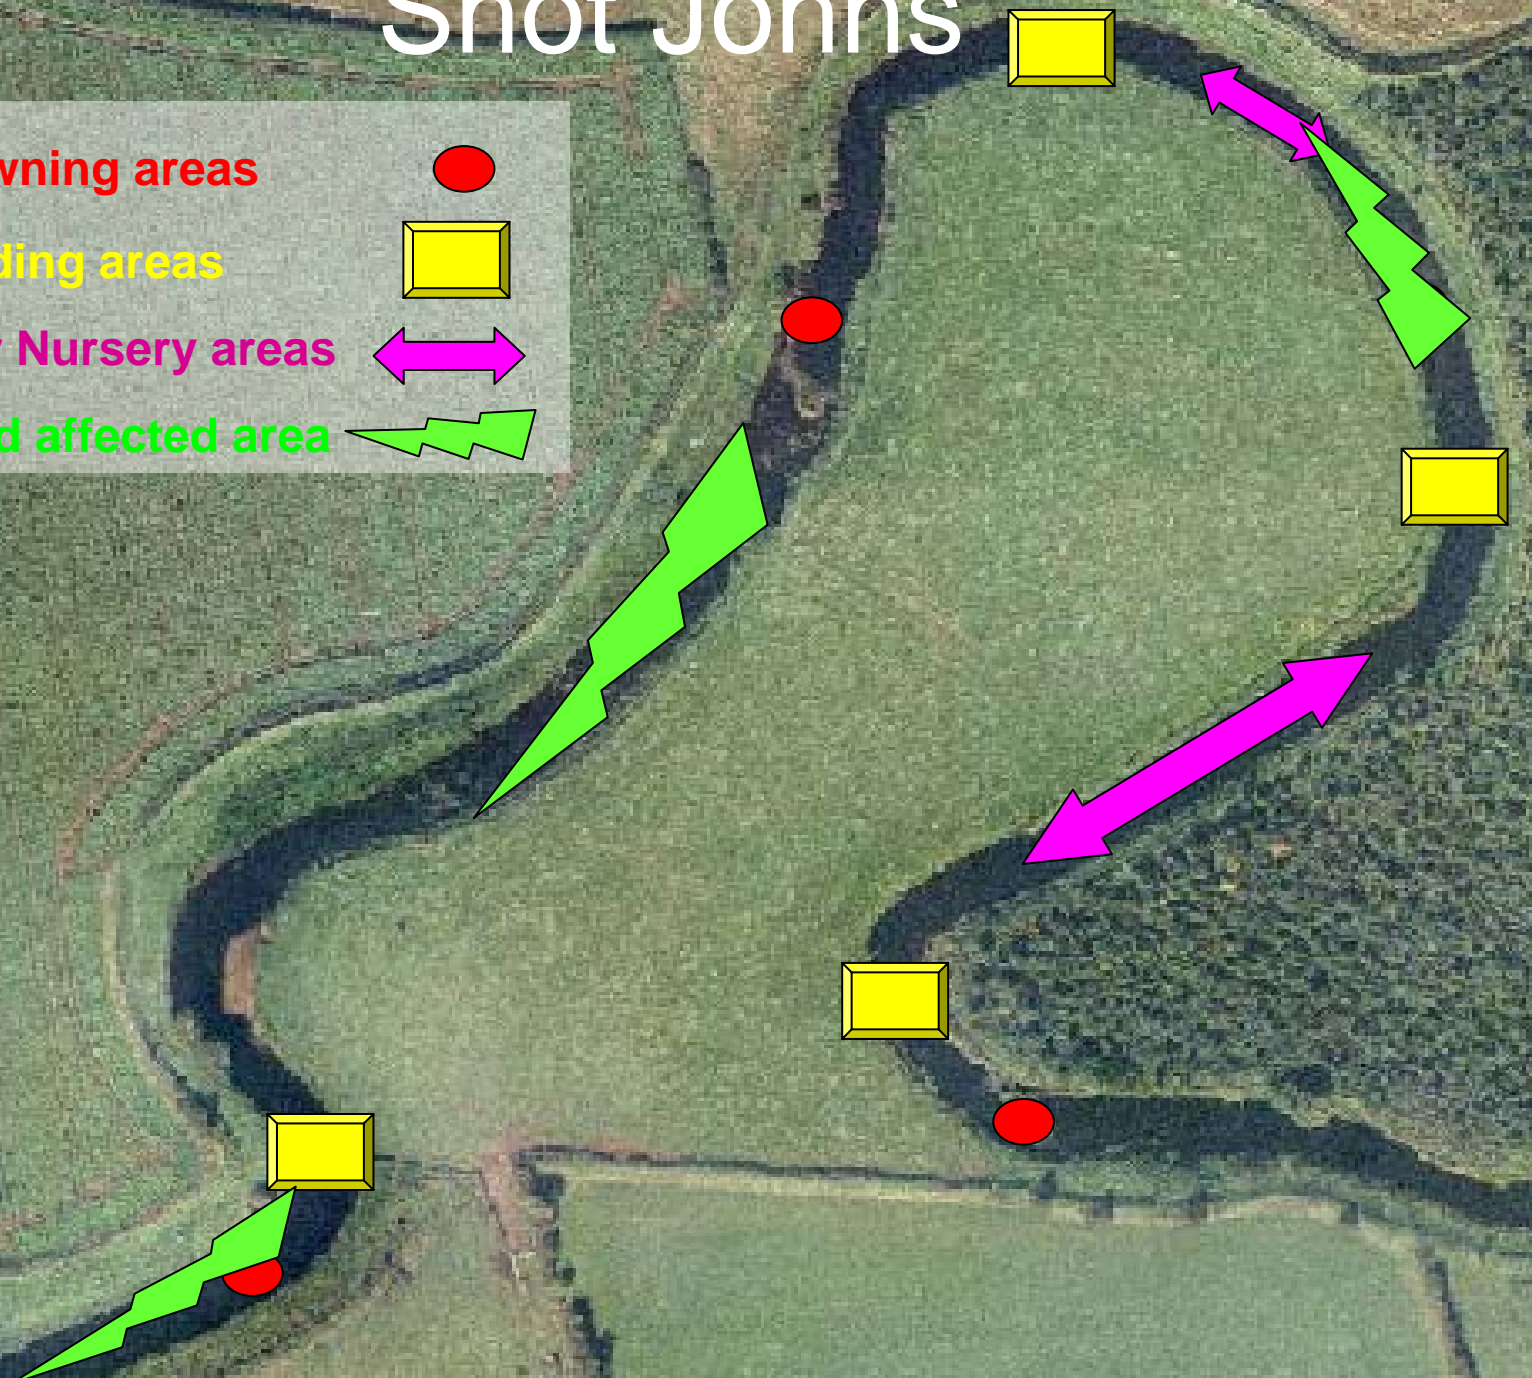
Shot Johns

Spawning areas ●

Holding areas □

Poor Nursery areas ↔

Weed affected area ⚡

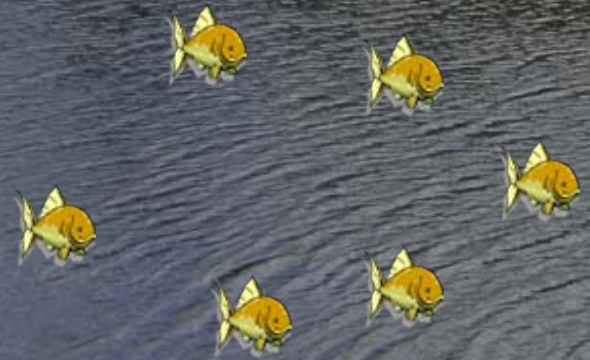
Poor Nursery habitat

- Uniform flow
- No cobble / boulders

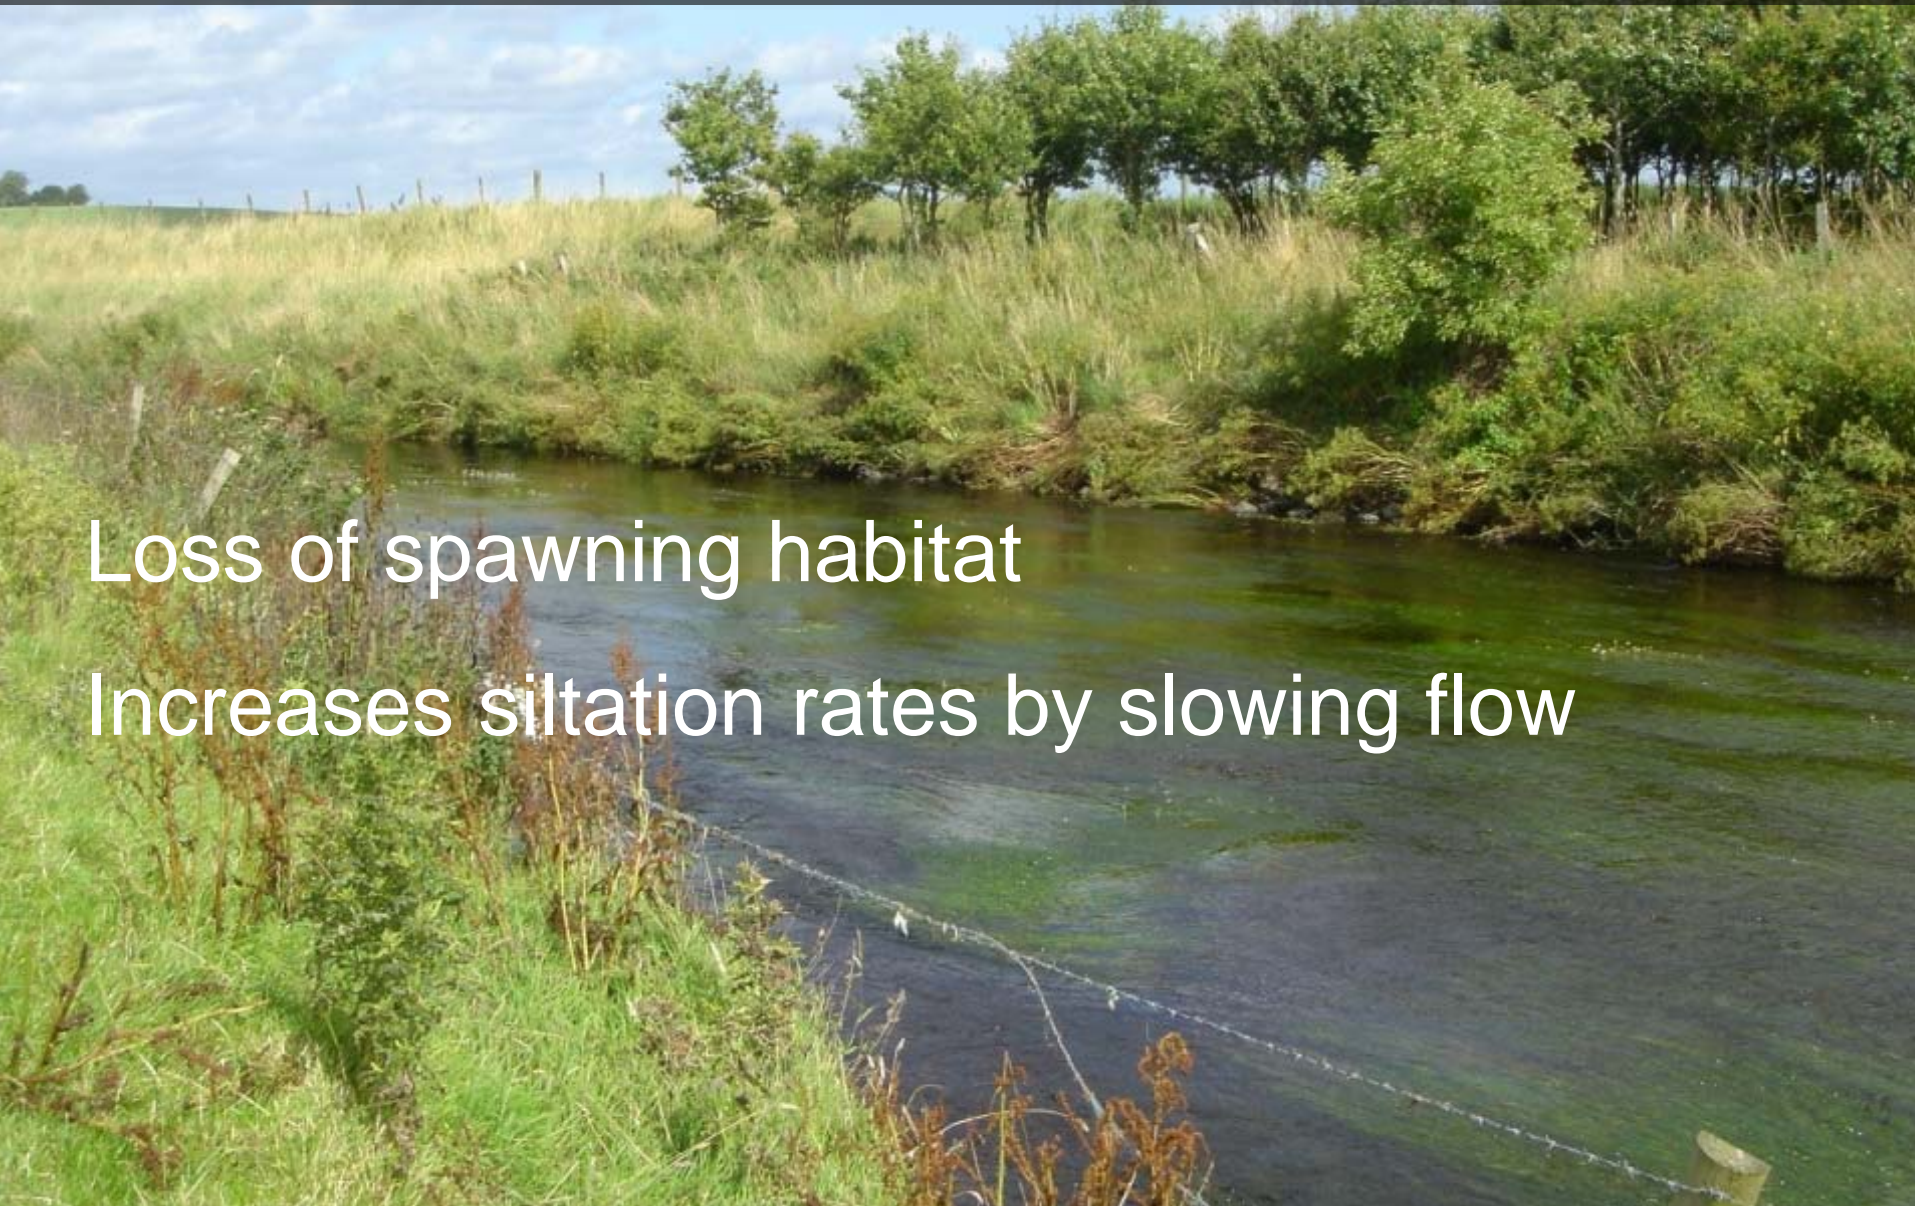
Ranunculus problem on spawning areas

Loss of spawning habitat

Increases siltation rates by slowing flow

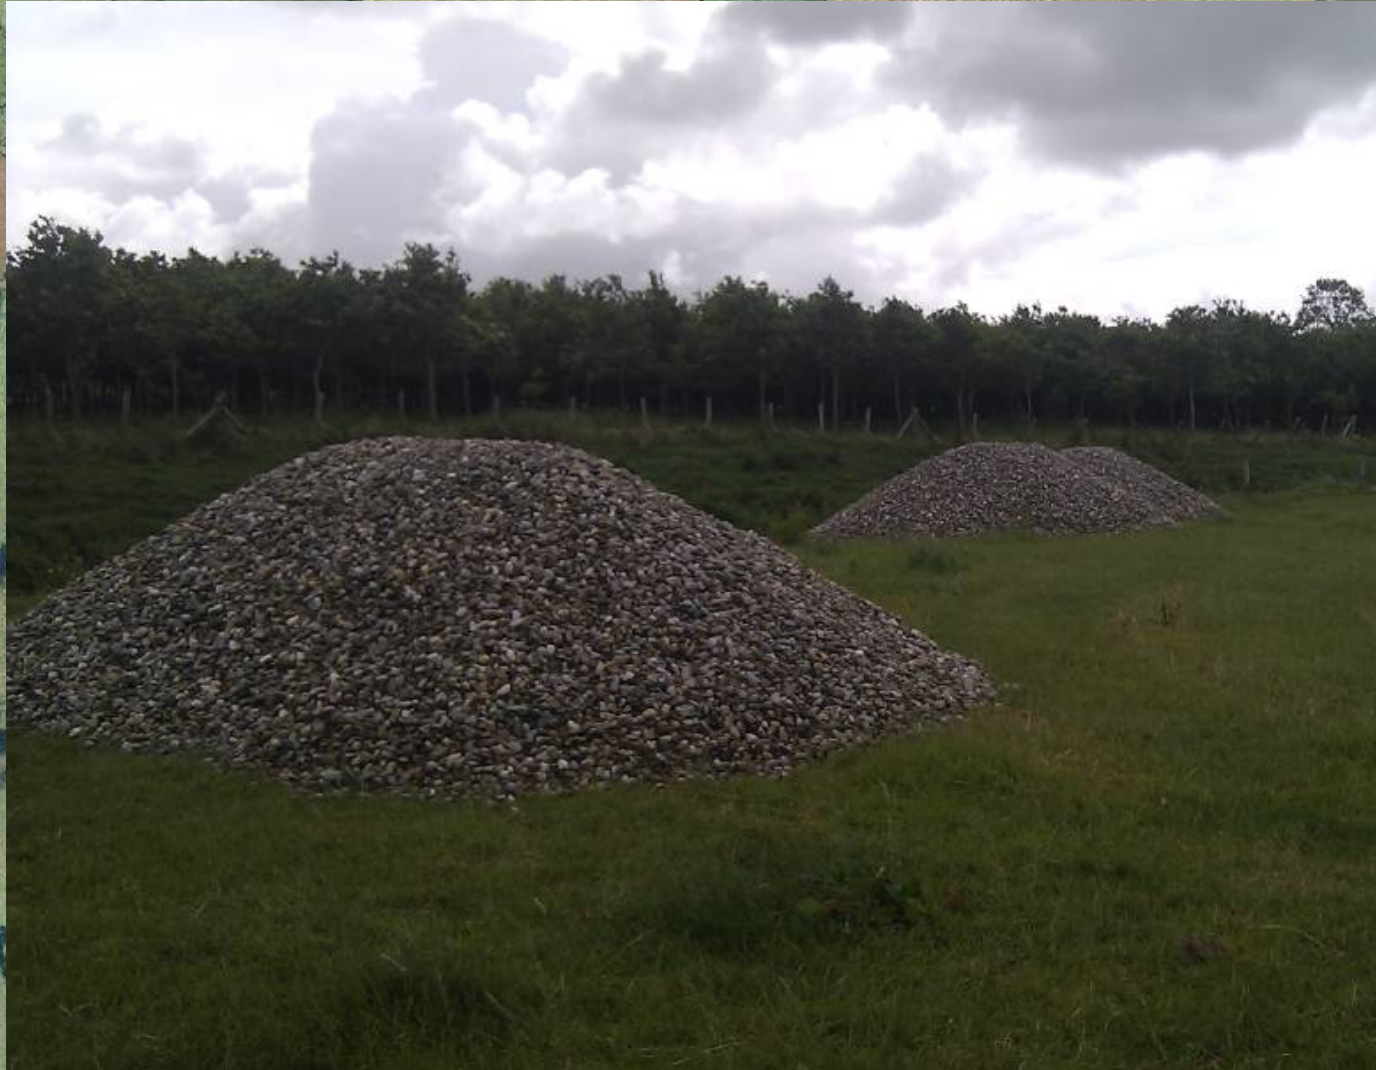
Cleaning and addition of spawning gravels

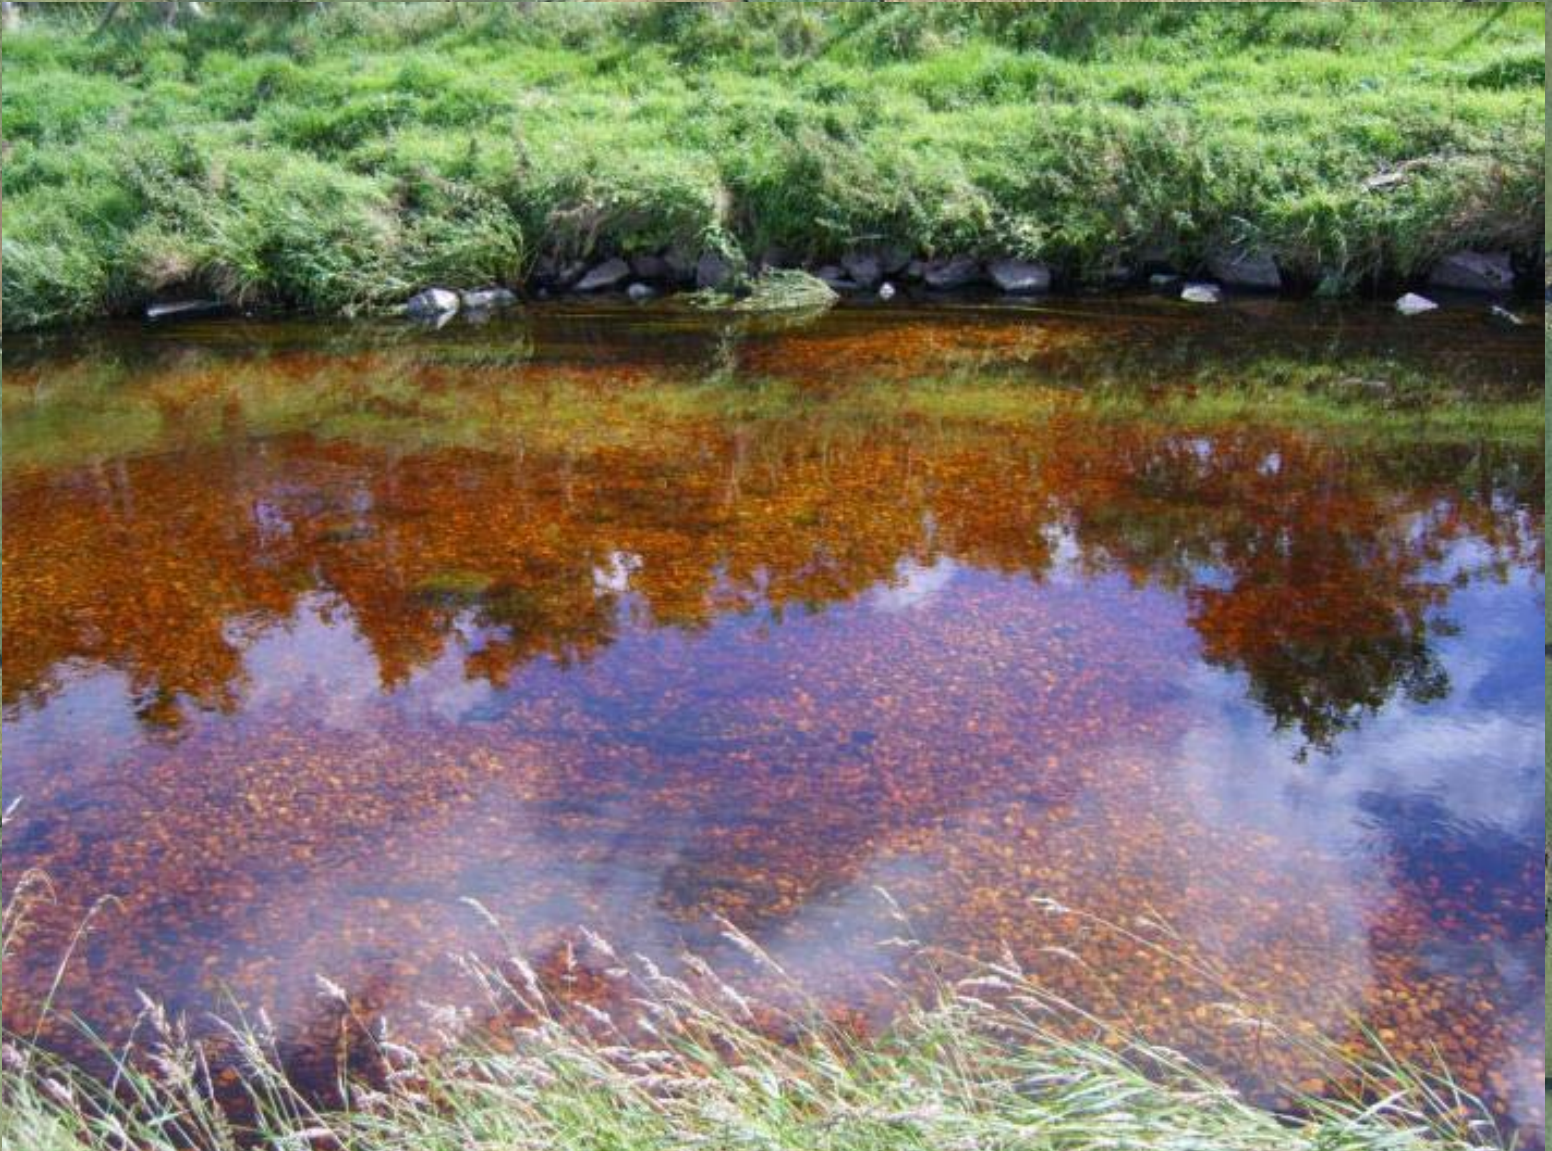
Cleaned gravels

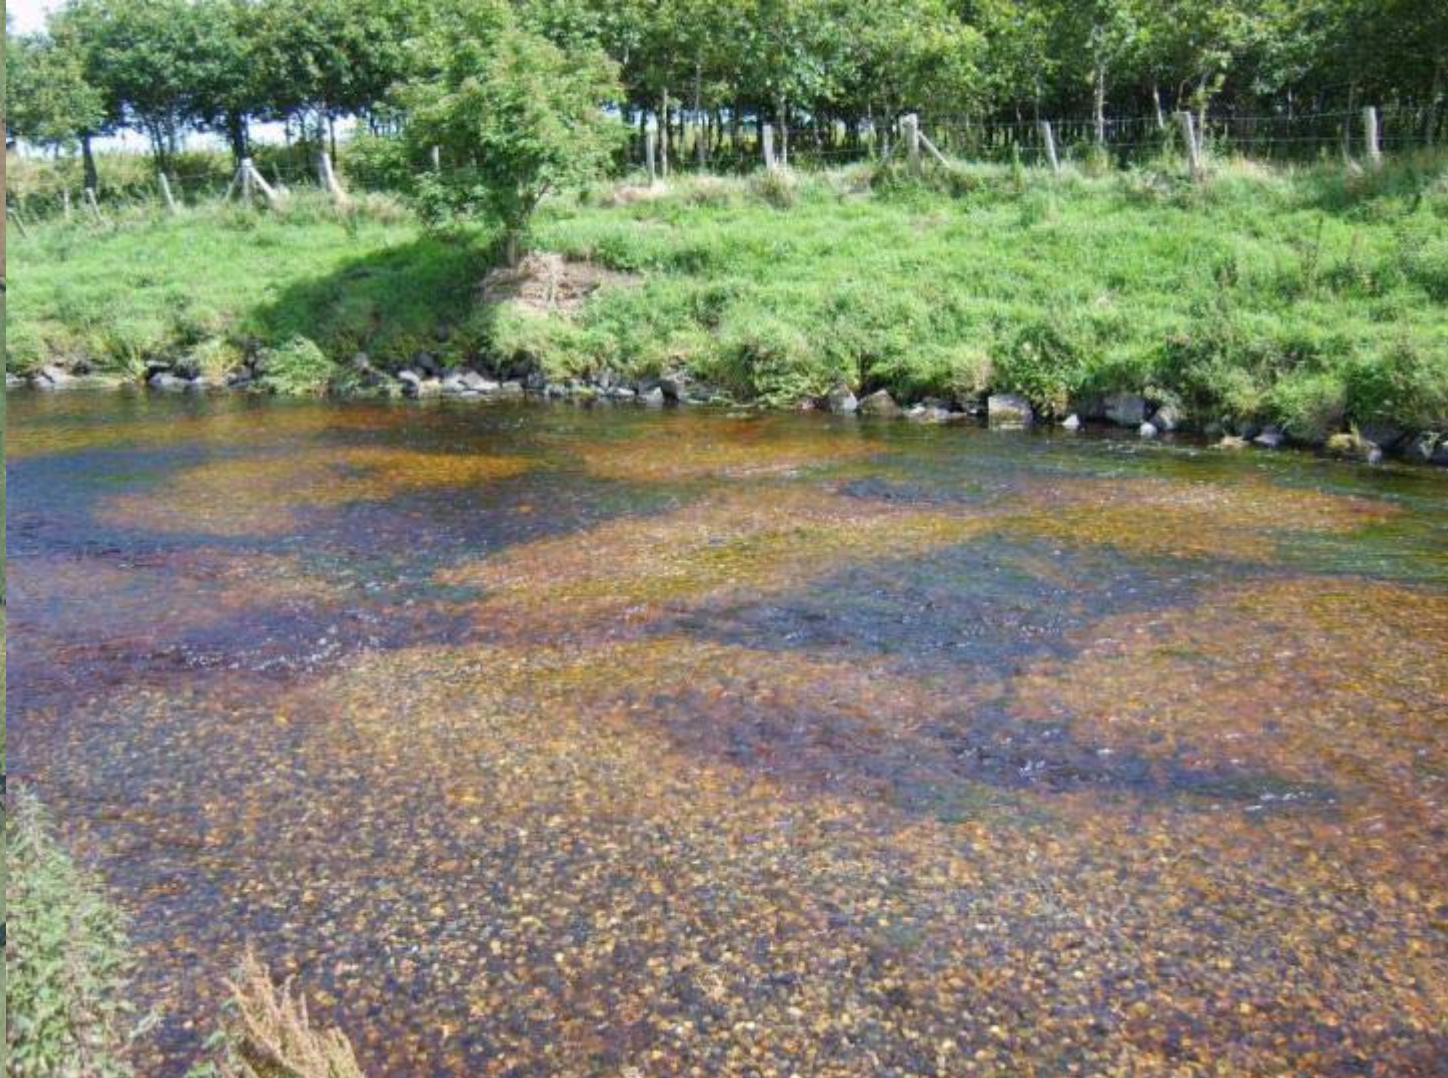
Removal of weed (chequer board cut)

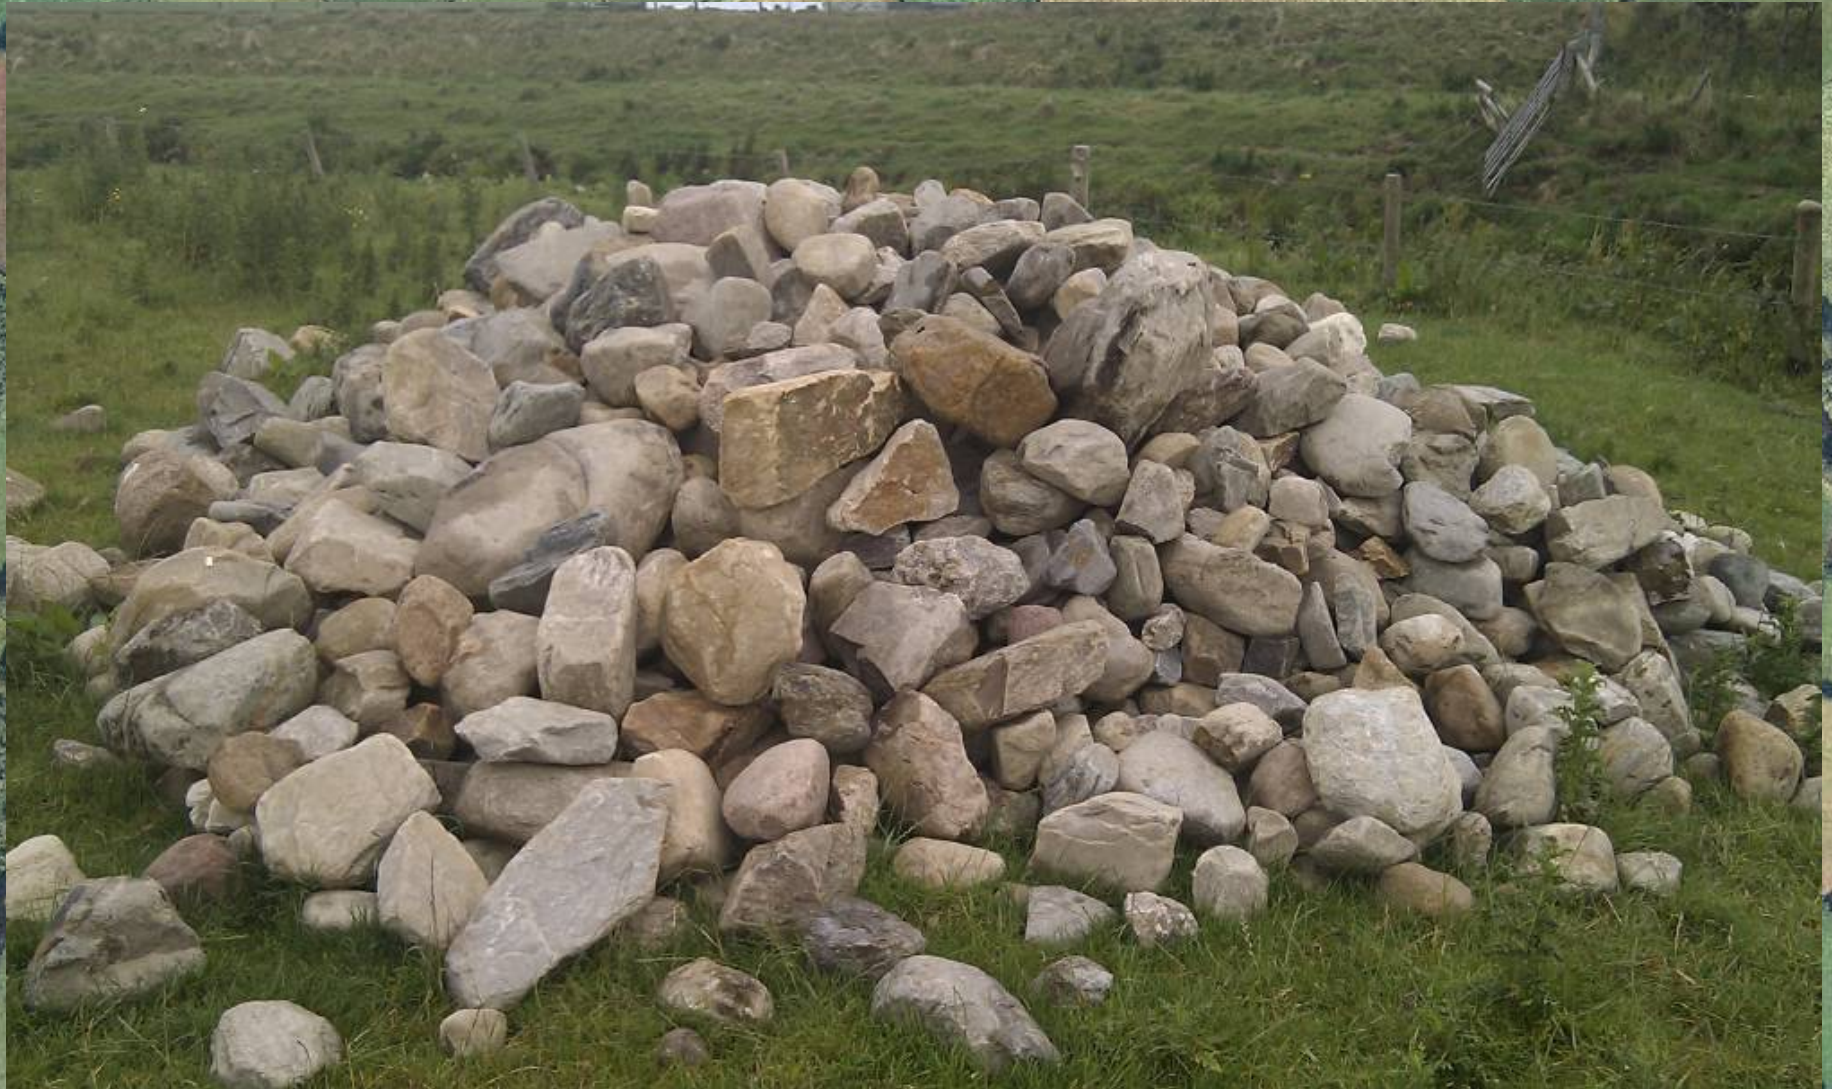
Addition of nursery stone
