# Buildings at Risk Down

*County*  
**DOWN**

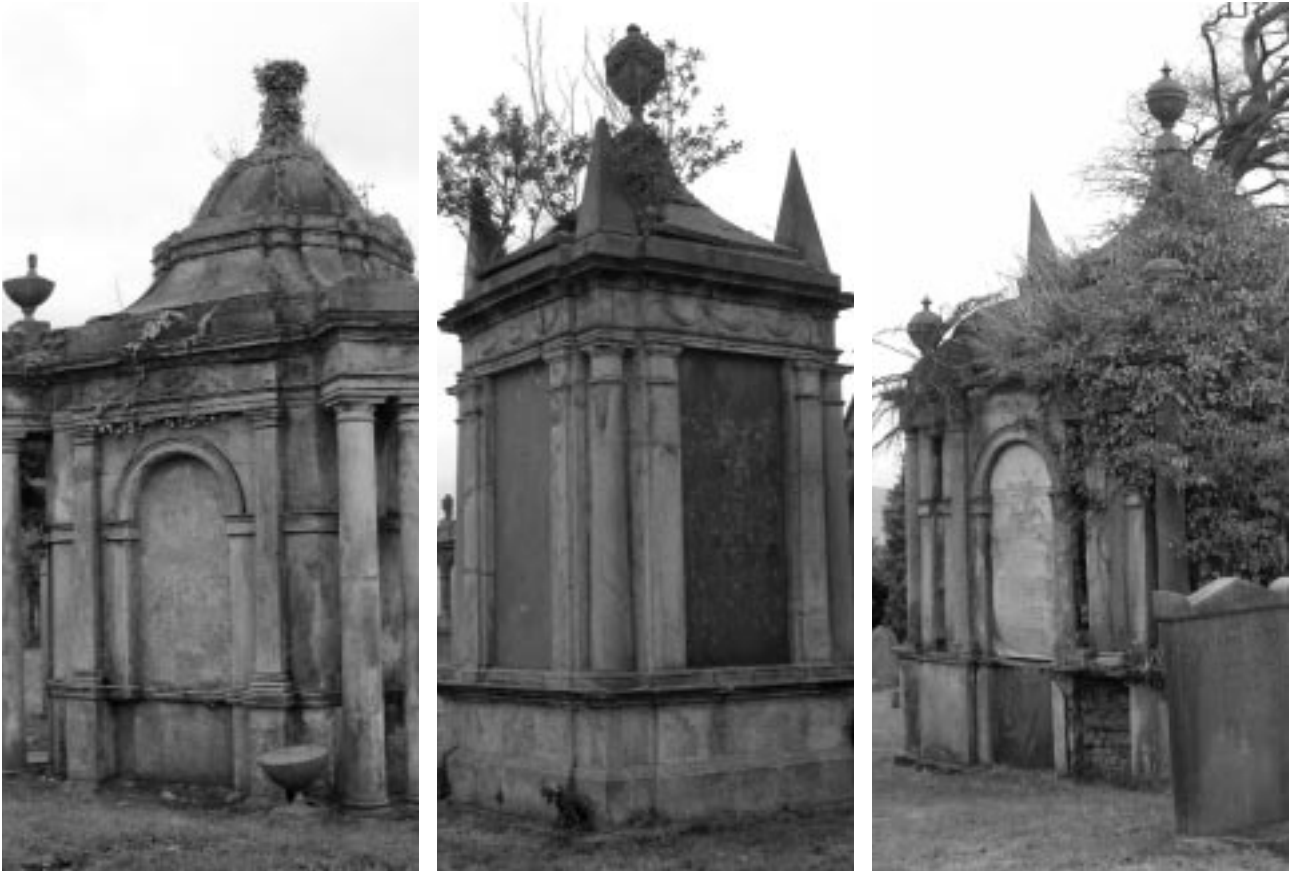
### WADDELL-CUNNINGHAM/RAINEY-GODDARD/ GREG MONUMENTS, KNOCKBRED A CHURCHYARD

This group of late-18th century mausolea in the churchyard at Knockbreda have appeared not only as buildings at risk, in *Buildings at Risk*, Vol. 4, p. 69, but have also featured in several other well-known architectural publications, each of which has noted their richly decorative design and their rarity. Despite this undoubted scholarly interest, all three are in a considerable state of disrepair. The Greg Mausoleum is arguably the most important of the three and is afforded a higher level of recognition, Grade B+, while the Waddell-Cunningham and Rainey-Goddard are both Grade B listed. The name of the architect to which the monuments' design should be attributed is, unfortunately, unknown.

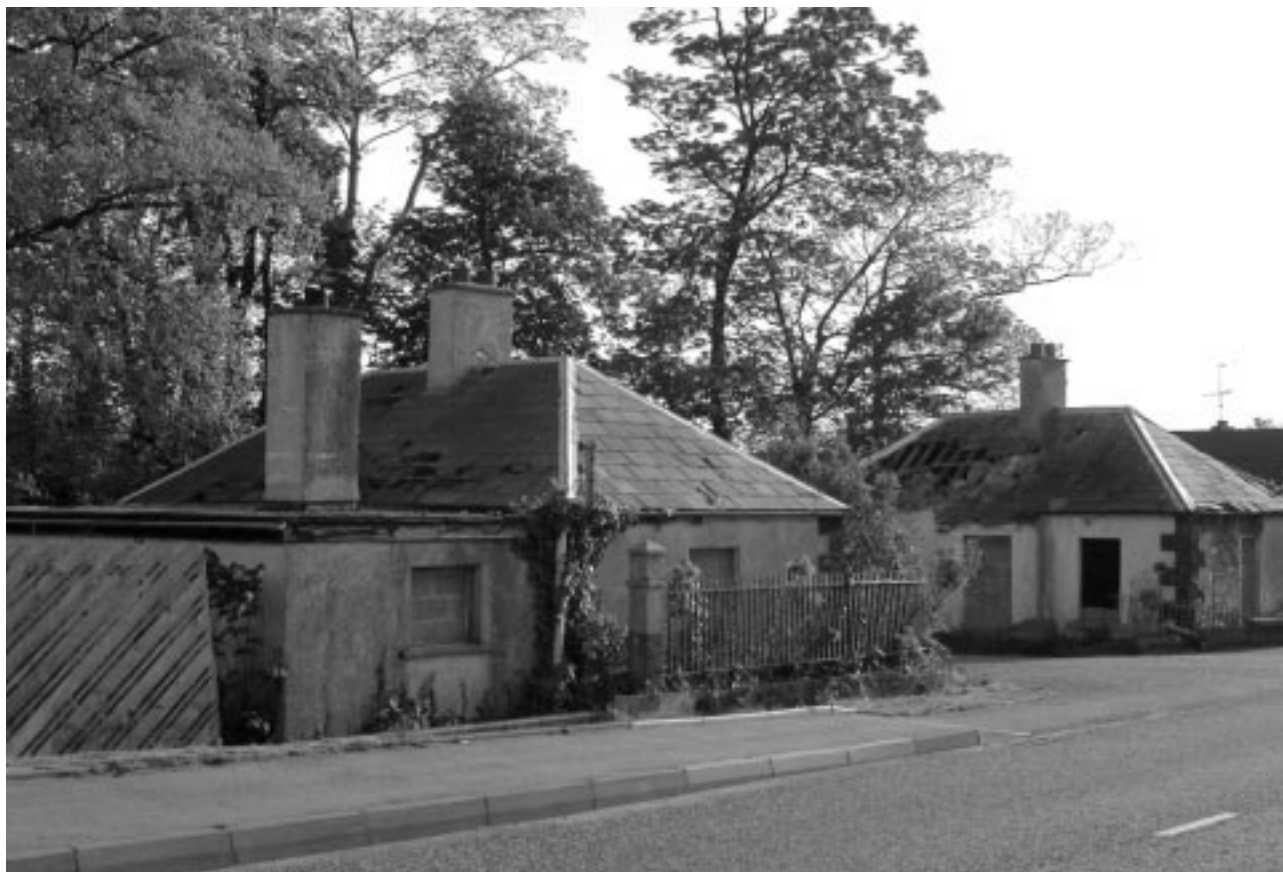
**GATE LODGES TO BROOKFIELD,  
65A & B SCARVA ROAD, BANBRIDGE**

Several sets of twin gate lodges have featured before as buildings at risk – at Castle Dillon House, County Armagh (*Buildings at Risk*, Vol. 6, p. 40) and at Pellipar House, County Londonderry (Vol. 3, p. 73). Like many standard lodge designs, they are often difficult to adapt or extend for modern living. Dean regarded the gate lodges at Brookfield House as “a modest pair of lodges facing each other across the avenue between inner and outer gate screens...single storey with hardly a vestige of architectural pretension”. Brookfield was once home to John Smyth, the owner of the Milltown Bleach Works at Lenaderg which was demolished in the mid-20th century although an attractive group of mill workers’ houses still remains. The condition of the lodges has deteriorated at a worrying rate over the last number of years and they have been subjected to serious acts of vandalism. As a group they form an important and ever-diminishing part of our heritage and, despite the difficulties associated with buildings of this type, they are more than capable of sustaining new uses.

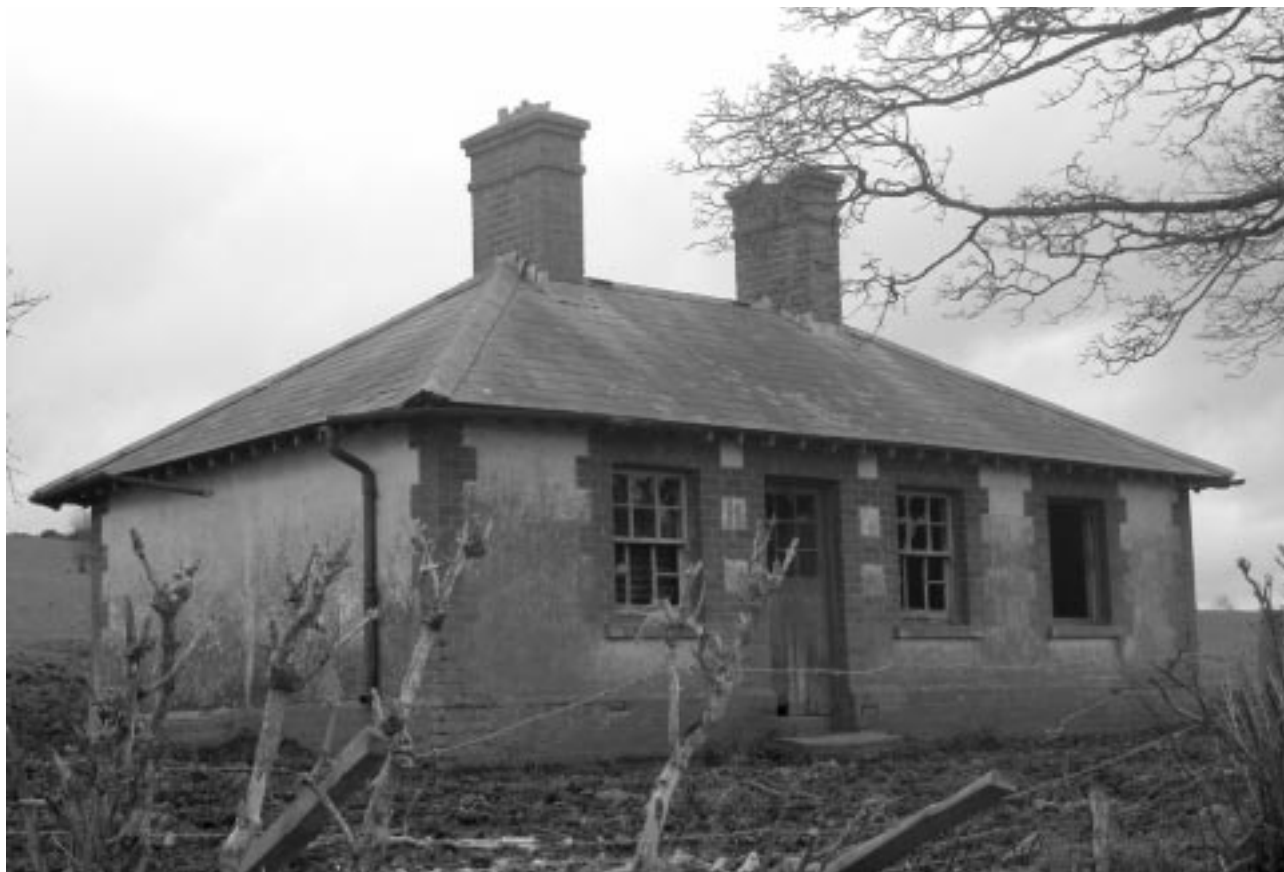
**SOUTH OF 16 ARDKEERAGH ROAD,  
DONAGHMORE, NEWRY**

Considered to be a rare surviving example of early council housing, this modest dwelling is now derelict, though full of character. Built prior to the First World War, it is a single-storey, three-bay, hipped roofed building with over-hanging eaves and exposed rafter ends. Two tall red-brick chimney stacks are prominent features, as are the striking red-brick surrounds to openings and quoins. In a poor state of repair, the building now stands idle, on agricultural land, sited close to a quiet country road.

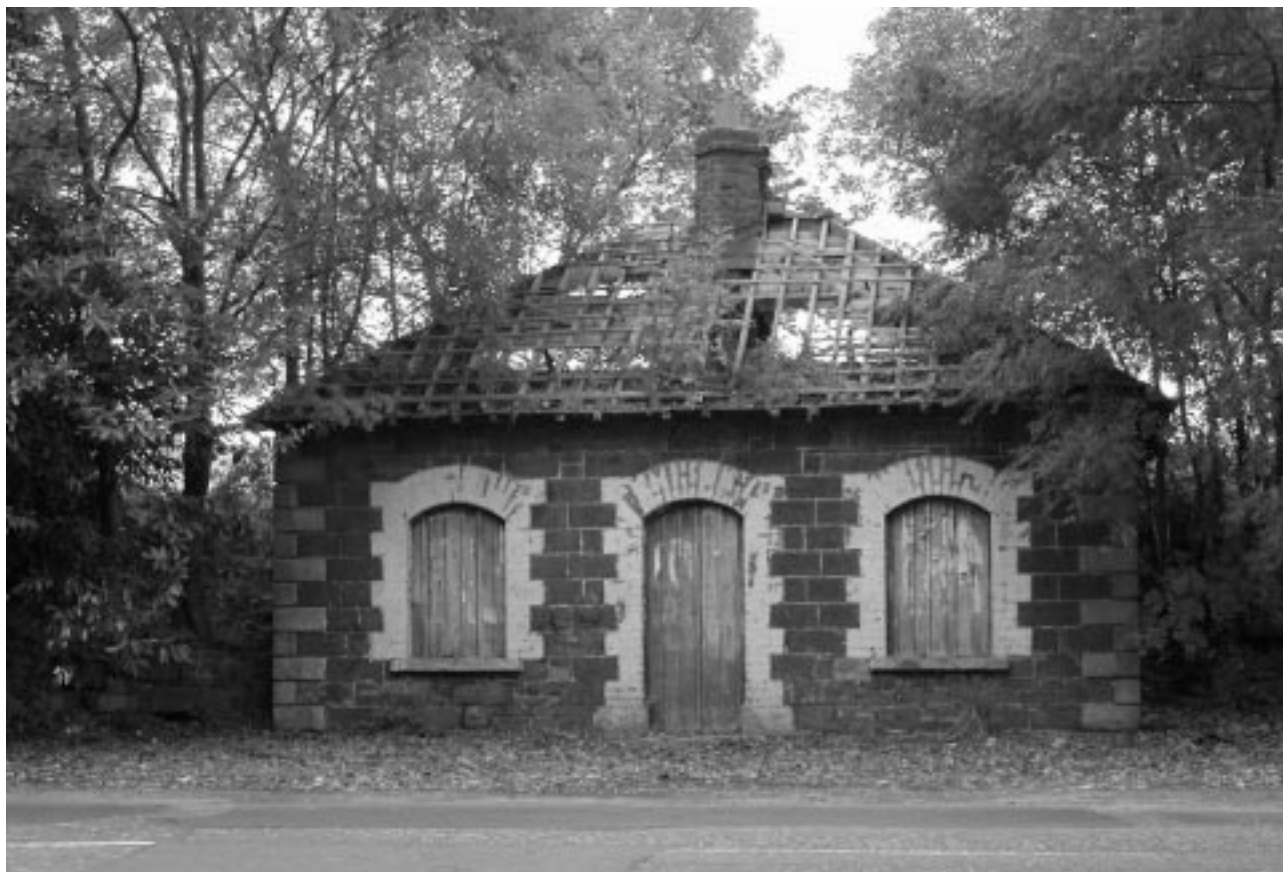
## 11 MOYALLAN ROAD, GILFORD

A sturdy mid-19th century lodge of great character, built for the Uprichard family of the Springvale Bleach Works. The standard, single-storey, three-bay building with a hipped roof is now in a serious state of disrepair and has deteriorated visibly since its appearance in *Buildings at Risk*, Vol. 1, p. 57, due to the removal of roof slates. Built of basalt with granite quoins, it is a building with great potential, sited on the fringes of the improving village of Gilford.

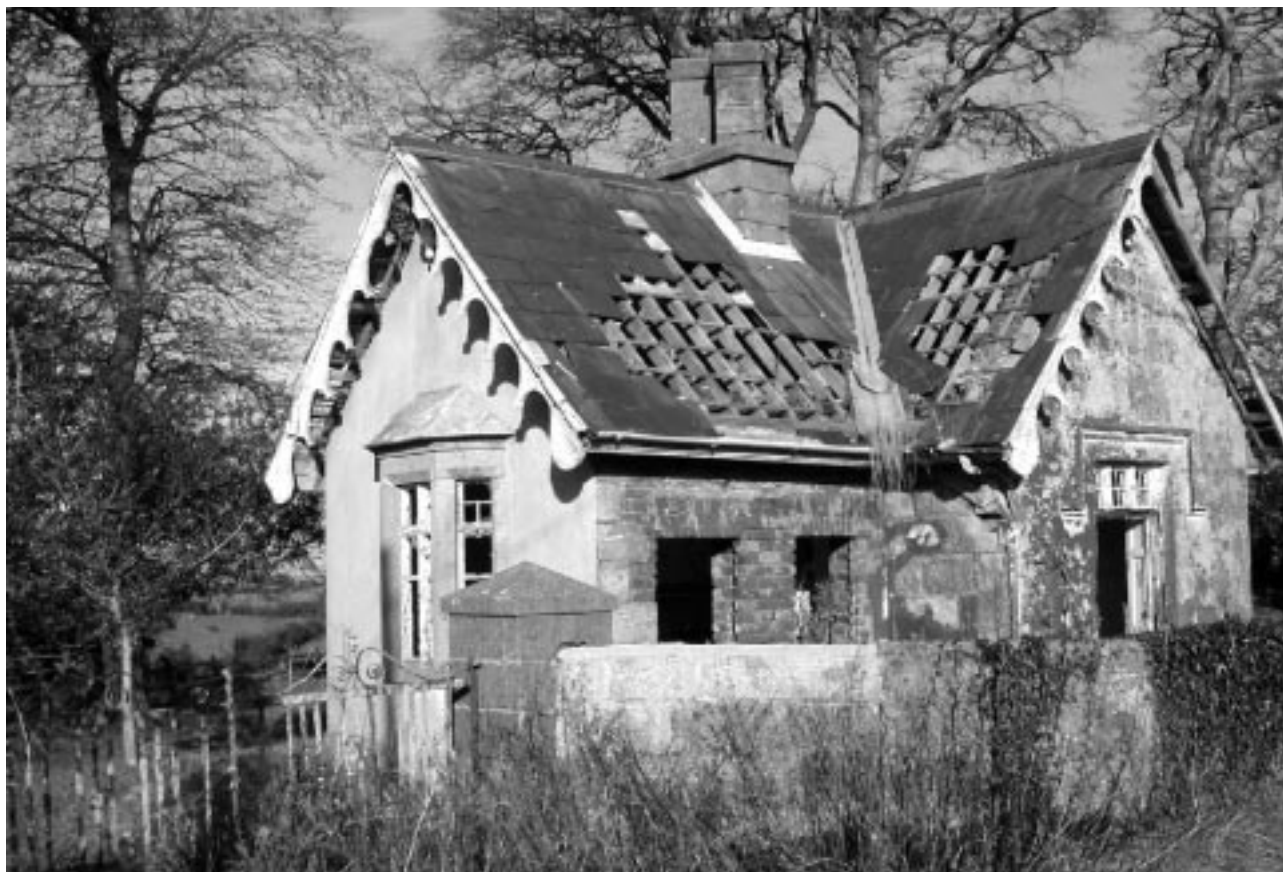
### EAST LODGE TO TAMNAHARRY HOUSE, BRIDGE ROAD, NEWRY

When this Thomas Duff designed lodge first appeared in *Buildings at Risk*, Vol. 3, p. 39, it was in an increasingly deteriorating condition, although Dean's description of it as being "a highly desirable building much in need of loving care and attention", was wholly accurate. Now, some 7 years later, the half-granite columns supporting the canopy have disappeared and the lodge is in a desolate state. It could still have a future, if placed in the hands of a caring restorer.

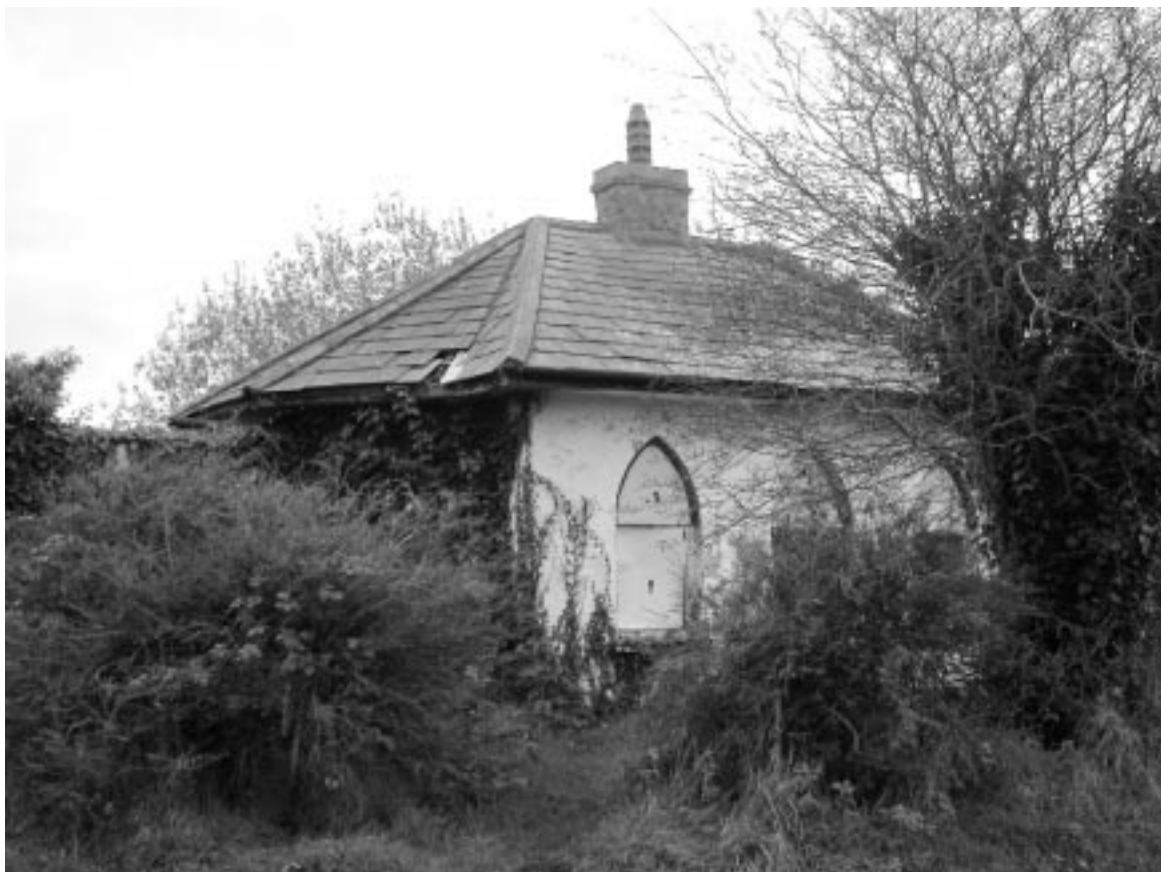
### **GATE LODGE TO FLORIDA MANOR, FLORIDA ROAD, KILMOOD**

Brett regards Florida Manor as a “rather mysterious house, probably of 17th century origin but much altered, with a disconcerting combination of possibly late 18th-century pompous tetrastyle Ionic porch and sprouting polygonal Elizabethan-style chimney-pots”. It was originally the seat of the Crawfords before being passed, by marriage, to the Gordons. The Georgian Gothic-style gate lodge was built c.1840 for David Gordon who was director of the Belfast Bank. Of the two original gate lodges to Florida Manor, the west lodge is the only one to remain relatively intact, although it is becoming increasingly overgrown. Typical in scale to other lodges – three-bay, single-storey with attic and a centrally placed chimney stack – its end elevations are canted to allow a more spacious interior. Lancet-headed window openings now incorporate what Dean considered to be “nasty modern metal windows”. The house, two-storey coach and farm buildings and pretty gate lodge are all now ‘at risk’. The lodge is also prone to vandalism, like so many other isolated and uninhabited buildings. A scheme for its reuse and extension has been devised but has yet to be implemented.

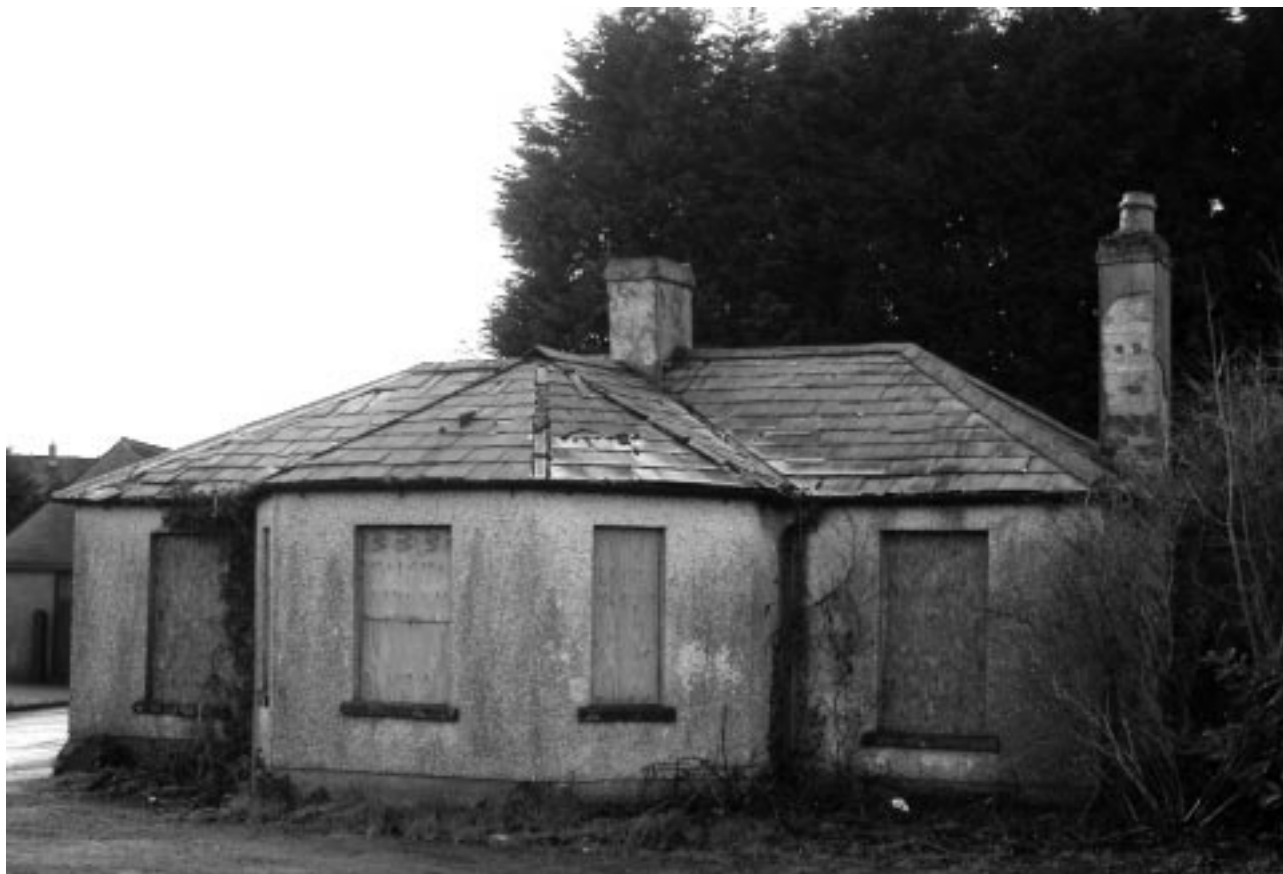
**TURNPIKE COTTAGE,  
131 HILLSBOROUGH ROAD, DROMORE**

Planning permission has recently been given for the restoration and extension of this early-19th century building, reputed to be the last remaining turnpike cottage in Northern Ireland. It is single-storey, T-shaped in plan with a hipped slated roof and, although in a poor state of repair for a number of years, has recently been fully boarded up. It featured previously in *Buildings at Risk*, Vol. 1, p. 56.

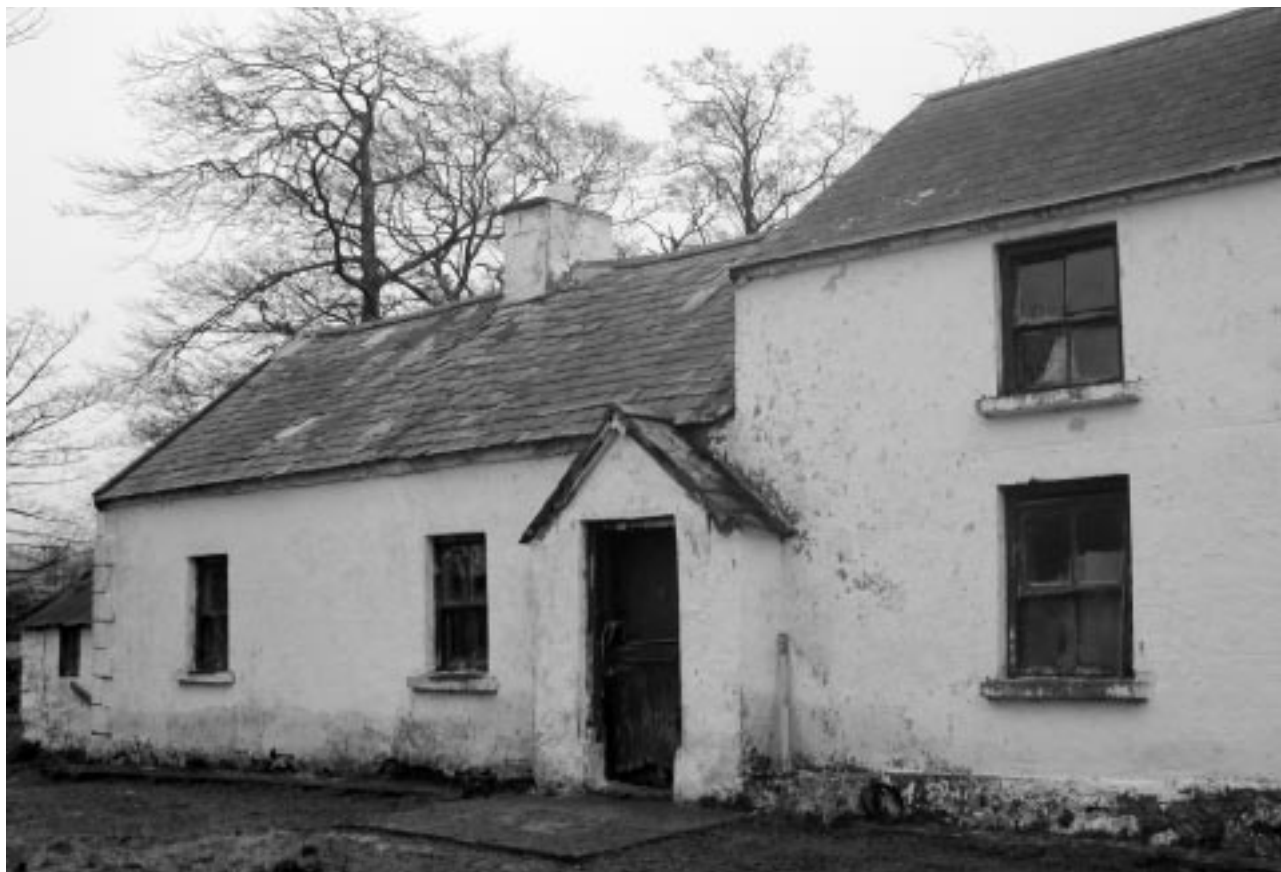
**14 COYLES HILL ROAD,  
MAYOBRIDGE, NEWRY**

On page xliii several of the vernacular properties that are currently being restored by the Mourne Heritage Trust were shown. These represent only a tiny fraction of the total number of such dwellings in the wider Mourne area that are vacant or derelict, although it is hoped that both the Mourne Homesteads Scheme and the likely designation of a Mourne National Park will have a positive impact on these numbers. This is an unusually unaltered vernacular dwelling of the early-19th century, nestled into the hillside looking across a narrow valley towards Slieveacarnane. It consists of a three-bay direct-entry dwelling house, partially two-storey with a natural slated roof, a muddy yard to the front and a range of outbuildings to the side. Internally its listing record suggests that it has an “unusual ‘cupboard’ staircase”, which further adds to its overall appeal. It is a wonderful building with a great deal of potential.

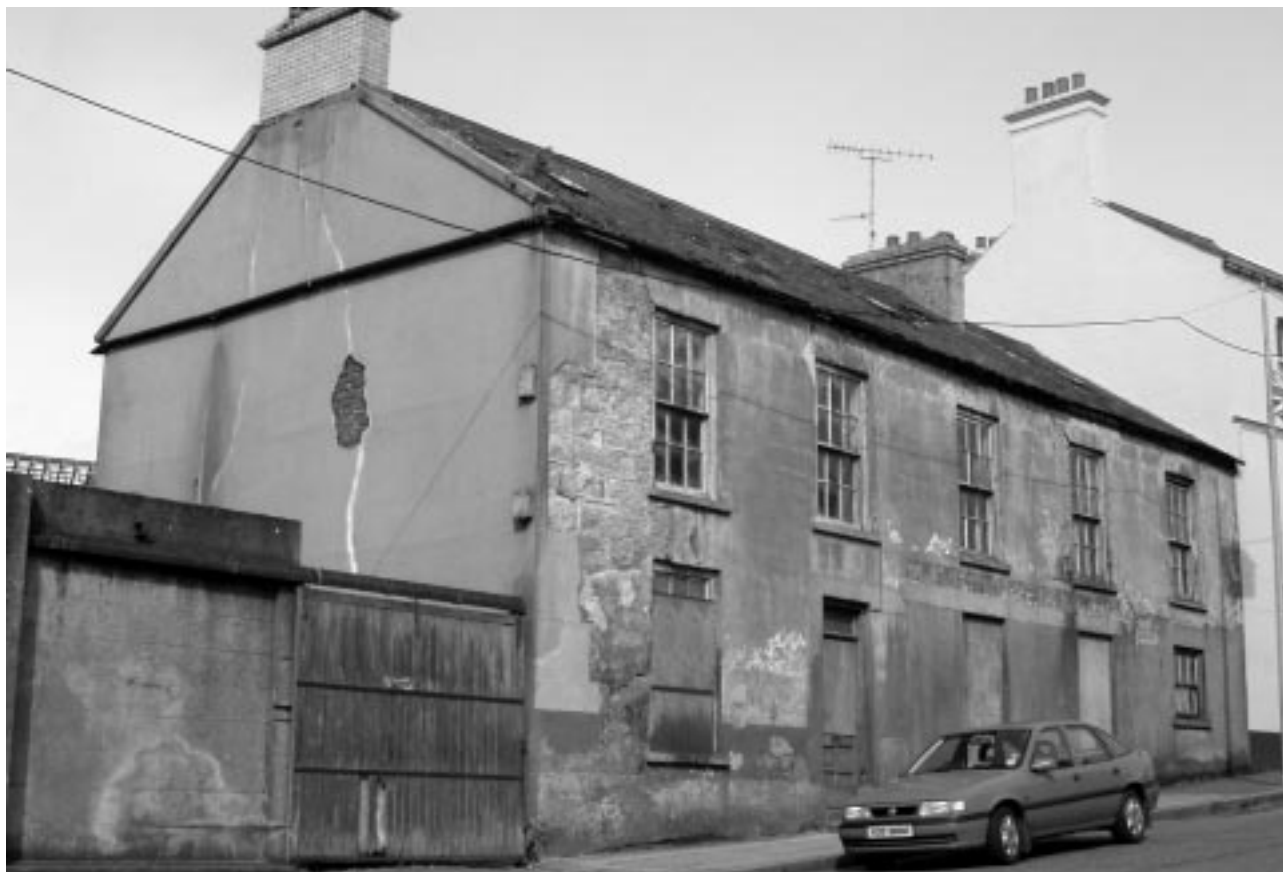
### 53 DOWNPATRICK STREET, RATHFRILAND

Forming an extremely important group with the neighbouring listed Fitzpatrick's, this rather forlorn two-storey, five-bay, late-Georgian house has further deteriorated since it was featured as a building at risk in *Buildings at Risk*, Vol. 3, p. 43. Rathfriland has featured often in buildings at risk and many of its fine older buildings remain vacant. It would surely be a worthy candidate for conservation area status, not just in recognition of its architectural and historical significance but also as a mechanism by which much needed funding can be attracted to regenerate the town sensitively.

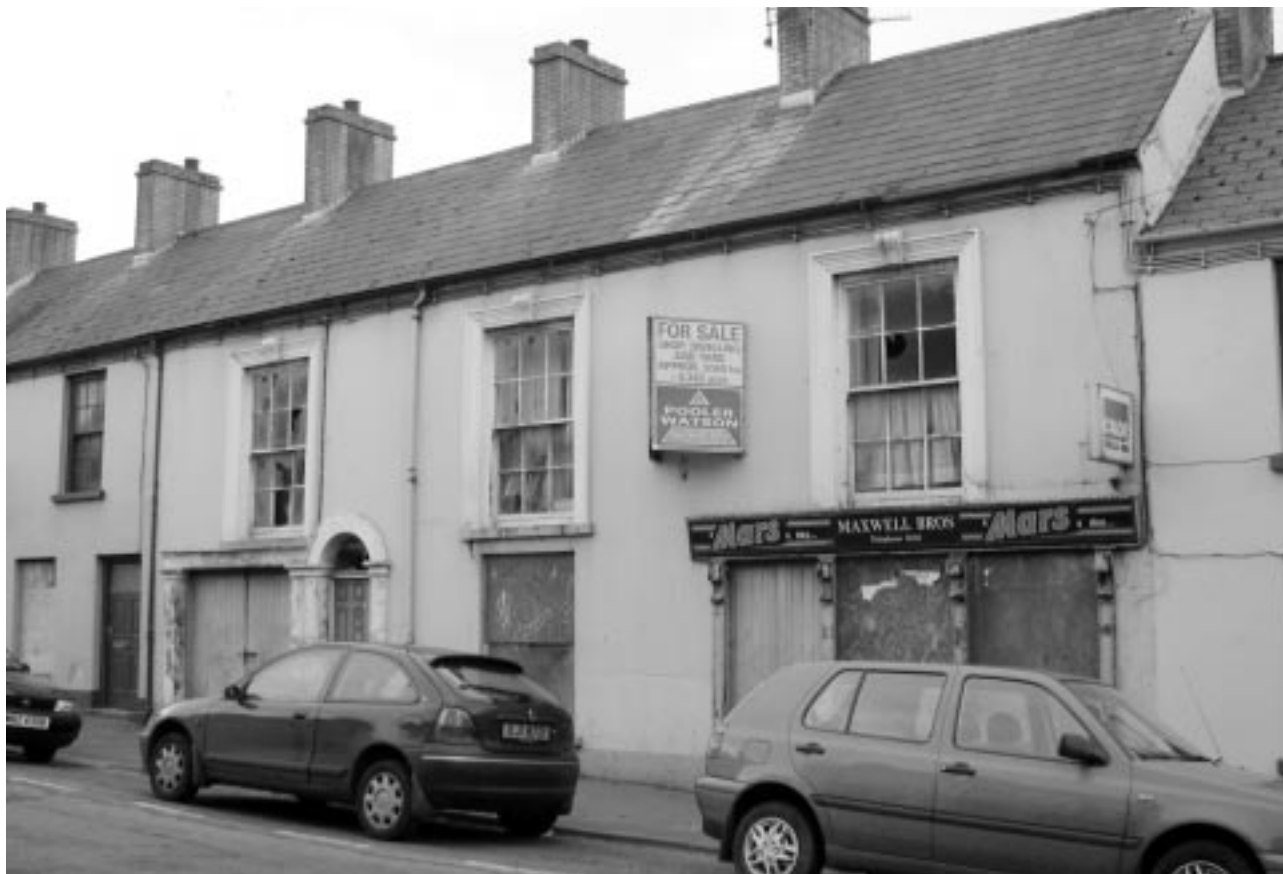
**35-37 MAIN STREET,  
KIRCUBBIN**

This part of the main street has been described as a “two-storey terrace block of possible late-18th century origin, large sections of which have been much altered in fairly recent times”. Those responsible for listing the buildings believe that the façade of nos. 35 and 37 possesses “a certain quirkiness”, which, “...may indicate that this section at least may have begun life as a single storey’. They are now boarded up, having been empty for a number of years. An application to demolish the adjoining property, which would have had a detrimental effect on the integrity of the terrace, has been rightly refused. They undoubtedly represent one of the finest pieces of urban streetscape in the catalogue and a local regeneration group is intent on their restoration and reuse, should sufficient funds be raised.

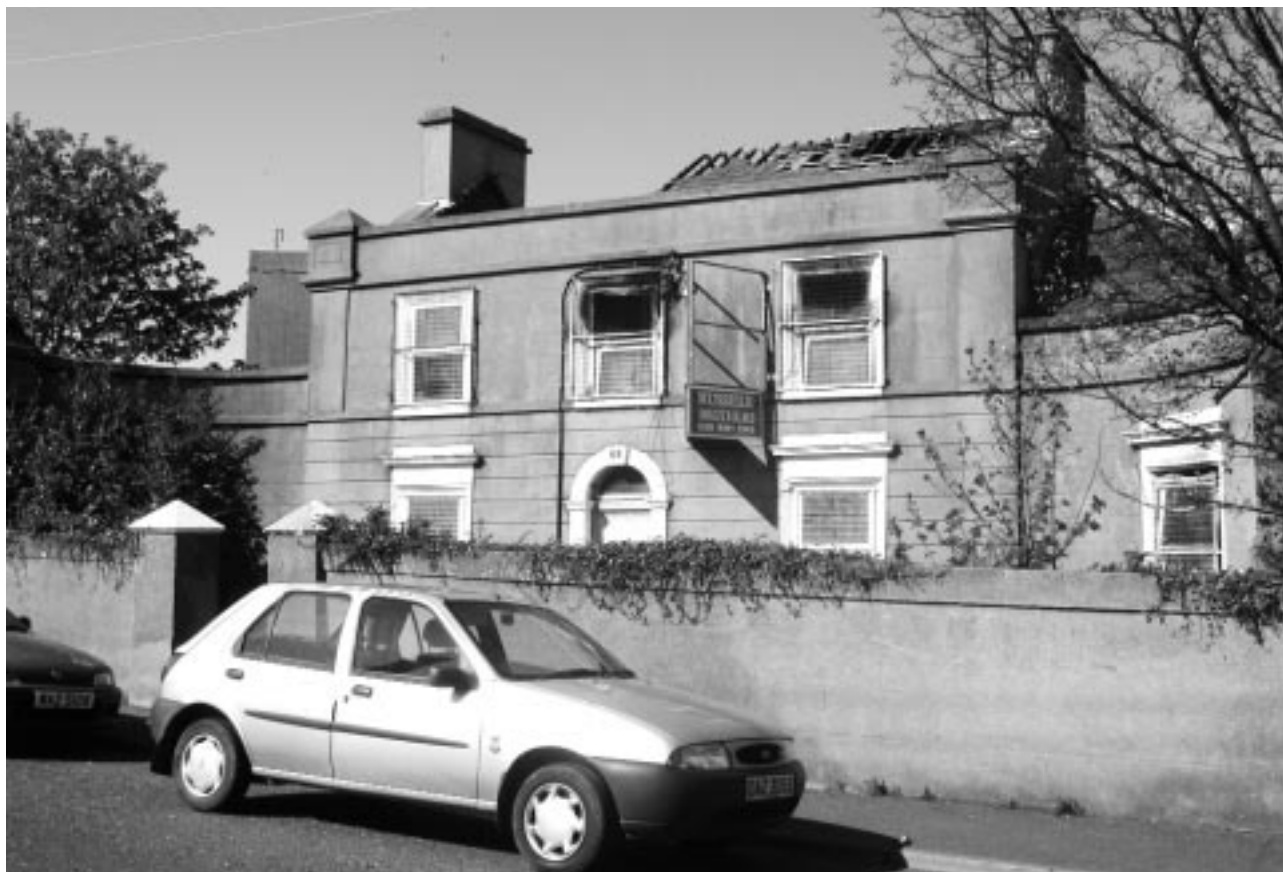
### **HARDFORD LODGE, 65 WEST STREET, NEWTOWNARDS**

This building is an unusual find in what is a narrow back street running parallel to Regent Street, one of the main thoroughfares in Newtownards. Formerly a house, it is a two-storey gabled building with outward curving wings at each end. Last used as an office, it recently suffered fire damage which has partially destroyed the roof structure, although the building appears sound.

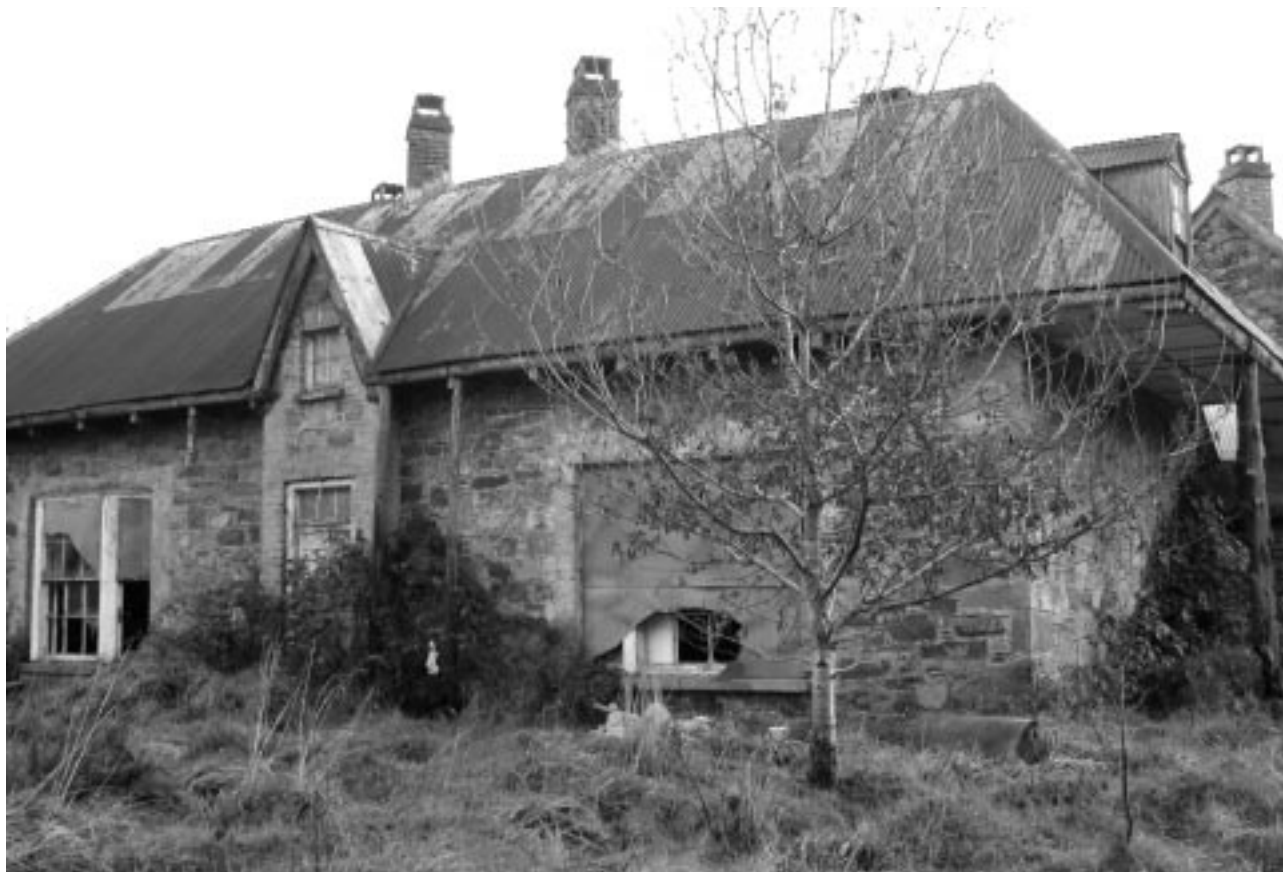
**BURREN WOOD,  
BURREN ROAD, CASTLEWELLAN**

A one-time cottage orné of the highest order, full of such vigour and interest as to merit a Grade B+ listing (reduced to B1 after the second survey), Burren Wood is now rapidly deteriorating and a testament to absenteeism. Built c.1820 by General Robert Meade, who had been left the land by his mother, the 1st Countess of Clanwilliam, it has been compared to Derrymore in County Armagh, well tended by the National Trust. The rambling thatched roof was replaced and covered with tin during World War Two but many other unusual features remain intact. It appeared in *Buildings at Risk*, Vol. 4, p. 65, since which time several parties have expressed a keen interest in taking on the enormous task of restoration. Its condition is such that the future of this unique building, together with its wooded setting, must be decided as a matter of some urgency.

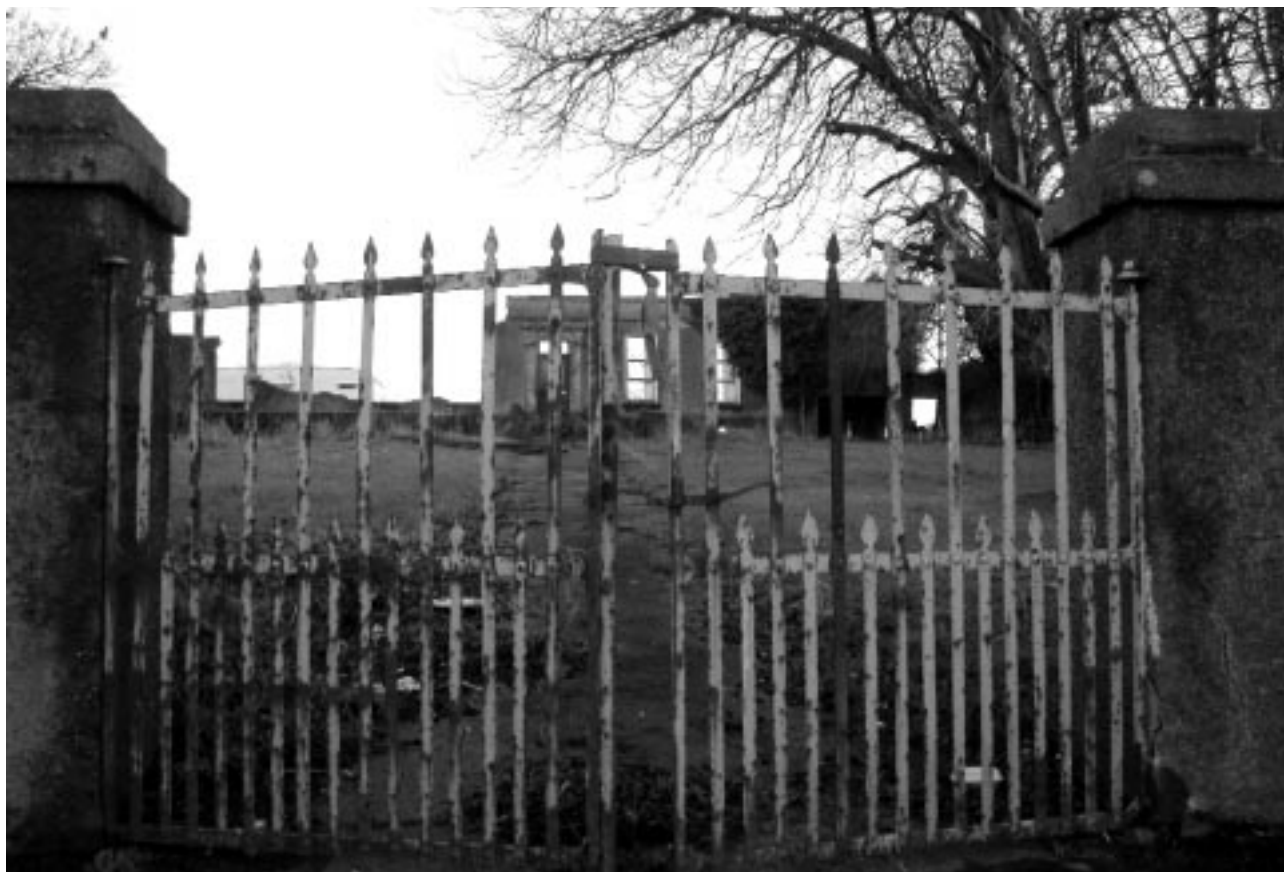
## CLOUGH HOUSE, 32 MAIN STREET, CLOUGH

Clough House was described in the UAHS list of 1972 as “an imposing stucco early-19th century house, 13 bays long, with bay windows at each end; doorcase with fluted Doric columns; glazing-bars complete in the central section”. It featured as a building at risk in *Buildings at Risk*, Vol. 1, p. 64, and was listed some 5 years later.

Unfortunately, its protected status did not deter the owner from partially demolishing the building without the necessary statutory approval and the site has lain derelict ever since.

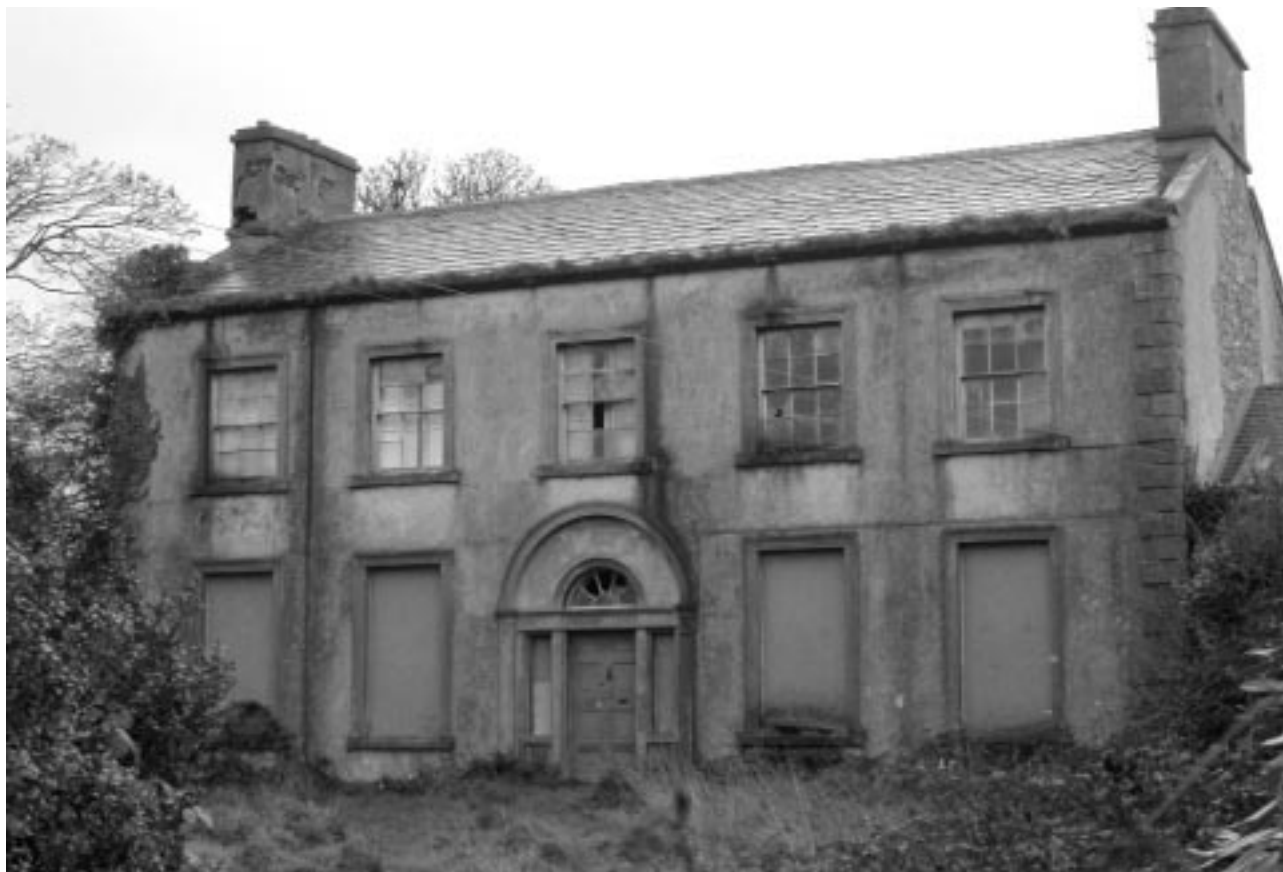
**HILLTOWN LODGE,  
CASTLEWELLAN ROAD, HILLTOWN**

Hilltown Lodge has been vacant for a considerable period of time. The UAHS list of 1979 in Rathfriland and Hilltown suggested that the building is “in need of restoration: the window frames and glazing bars starting to disintegrate, the garden all in long grass”. This was some 15 years prior to its appearance as a building at risk in *Buildings at Risk*, Vol. 1, p. 68, where it was said that “...no major restoration or holding repair work has been carried out [since 1979]”. Despite this neglect, it remains an important listed building, rare and irreplaceable and deserving of a positive future. It is hoped that a suitable scheme of repairs can be undertaken to safeguard its future, or, at the very least, to check its prolonged deterioration.

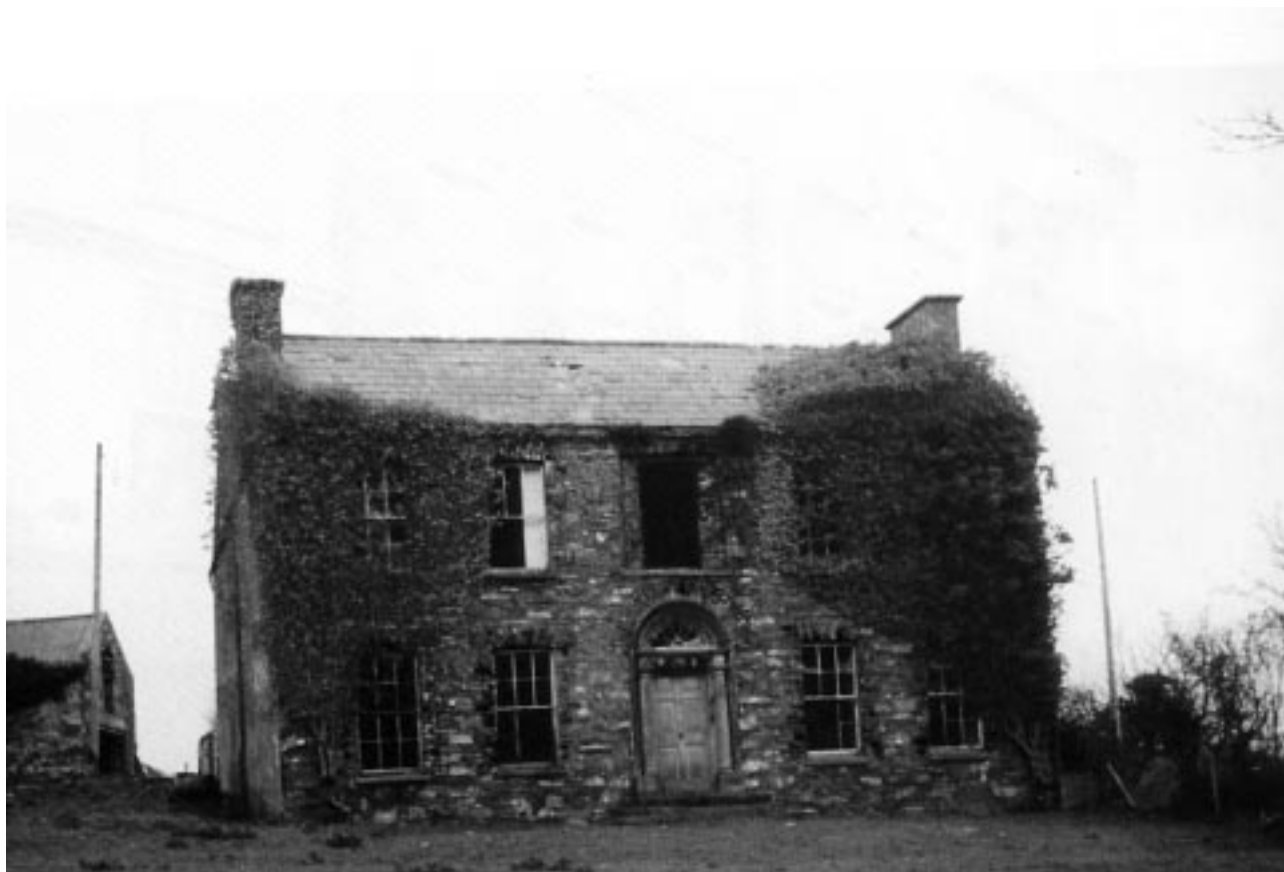
**ROSSCONOR HOUSE,  
65 ANNACLOY ROAD, ANNACLOY**

Rossconor House sits rather oddly in the midst of ribbon development in the heart of the County Down countryside. Built around 1800, it is a relatively modest two-storey, five-bay, double-pile country house with a particularly fine panelled door, flanked by columns and surmounted by an attractive radial fanlight. A number of new dwellings have encroached upon its setting over the years and the building itself, which has not been occupied for several decades, is now in a very poor state of repair.

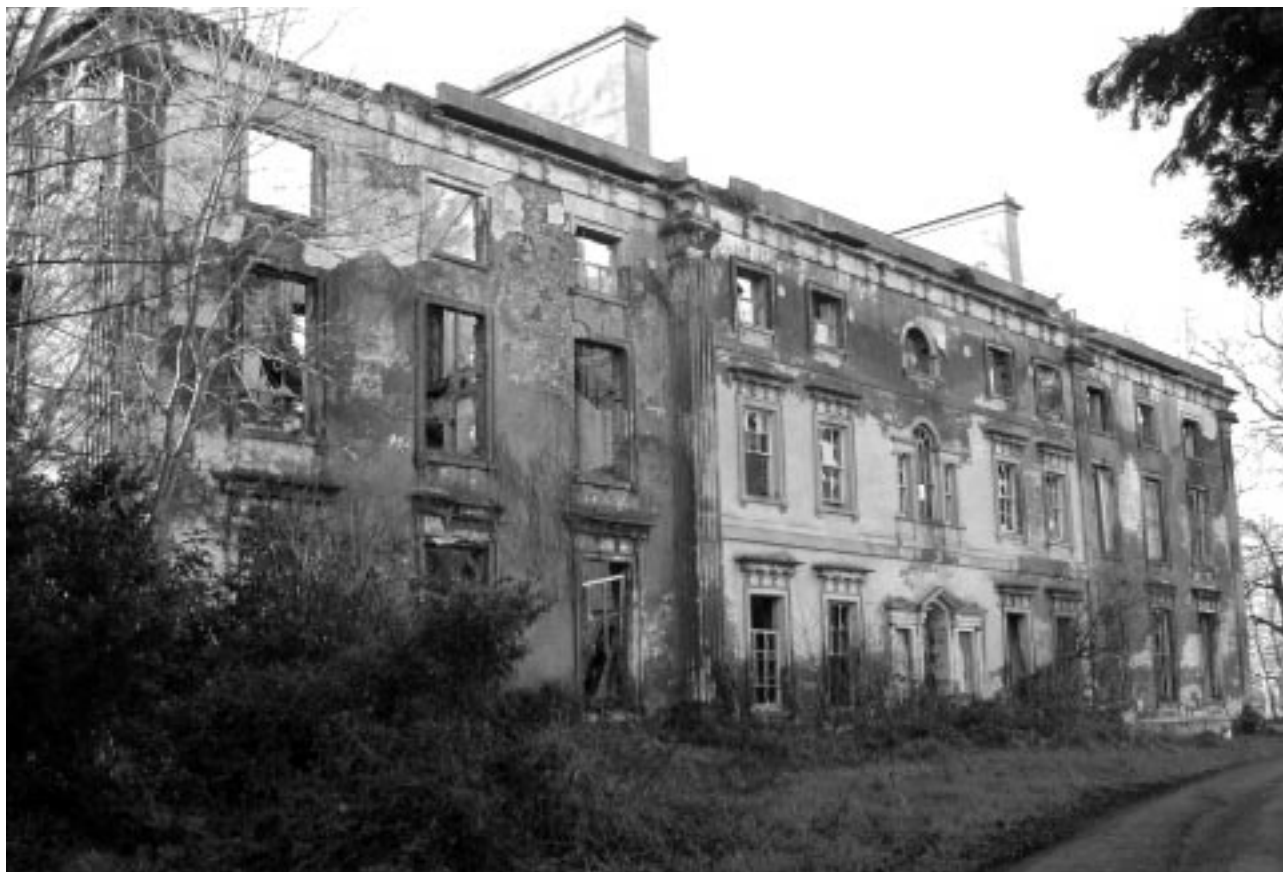
## **MOUNT PANTHER, DUNDRUM ROAD, CLOUGH**

Mount Panther is a building of considerable merit in a state of utter dereliction which poses a significant headache for its future reuse. Built c.1770, it is an eleven-bay, three-storey edifice with basement in modified Palladian style. It occupies an elevated position near the village of Clough with its high chimney stacks being clearly visible from the Castlewellan Road. Once famous for its ballroom which contained exceptional rococo plasterwork, all of this interior is now in ruins, along with the substantial two-storey stable yard to the rear. It appeared in the very first *Buildings at Risk* catalogue (p. 73) and remains a very important historic building.

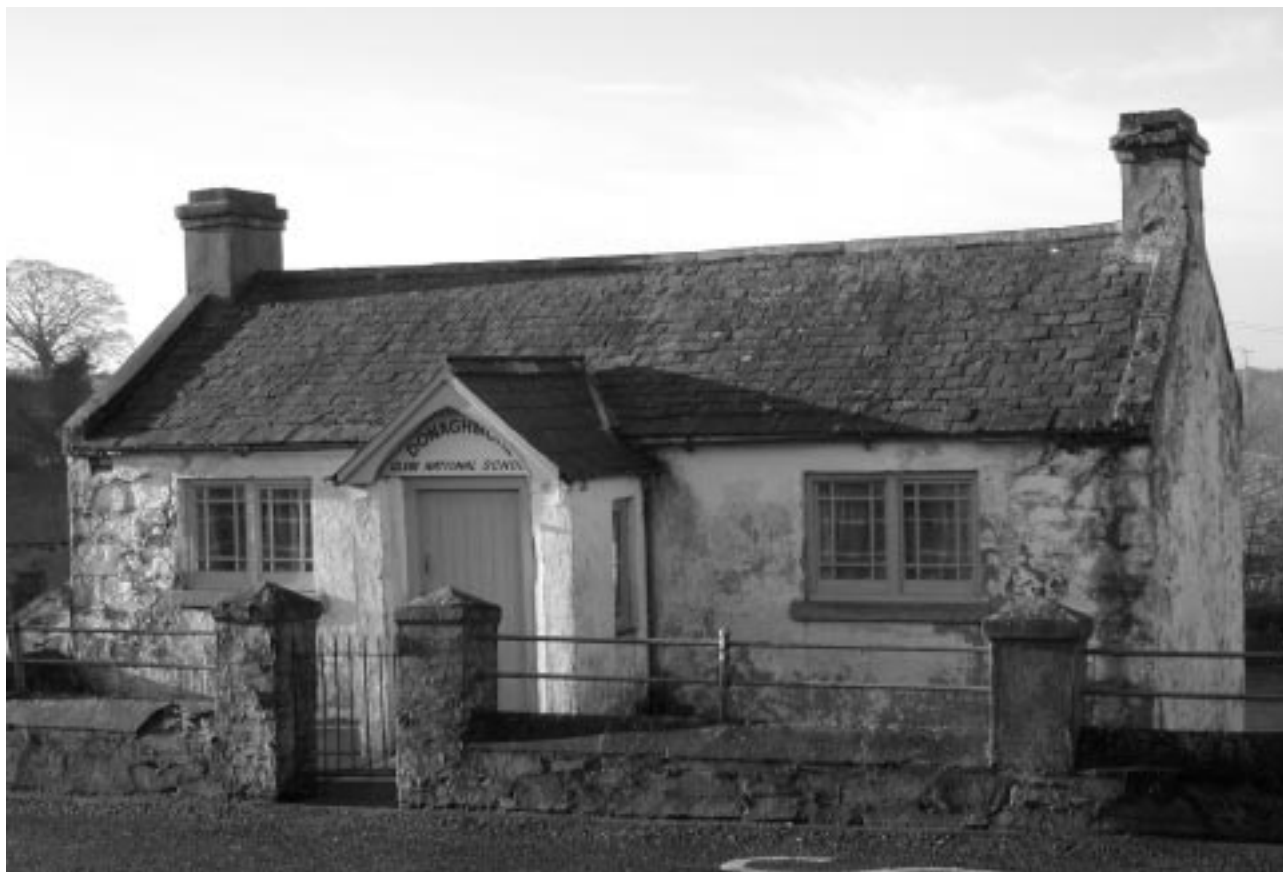
### GLEBE NATIONAL SCHOOL, DONAGHMORE, NEWRY

Part of an important historical grouping at Donaghmore crossroads, along with the nearby church and former Glebe House (see *Buildings at Risk*, Vol. 4, p. 62), the charming and beautifully situated split-level former Glebe National School remains vacant and at risk. Built in 1818, it is a plain vernacular type building considered to be “in virtually original condition” and was recently listed by Environment and Heritage Service under its second survey of historic buildings. It appeared previously in *Buildings at Risk*, Vol. 4, p. 61, when it was likened to the Madden National School near Armagh (*Buildings at Risk*, Vol. 3, p. 35). Madden is to be reused as a community hall. However, no such plans exist for the long-term future of this former school, although it is generally well tended by the owners.
