# BONAMARGY FRIARY

## BONAMARGY FRIARY

County Antrim

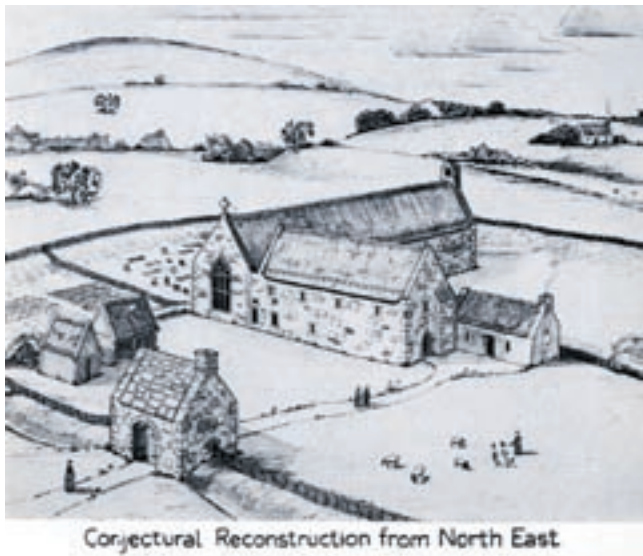
The Church is a long narrow rectangle (internally 99 by 24 ft. 6 ins.), the common friary plan, but with no sign of the tower which distinguishes so many friaries. The tall E. window is impressive, even in its damaged state. The shaded area in our drawing is a hypothetical reconstruction of the flame-like (flamboyant) tracery. The surround is grooved for glass and behind were iron bars. The external decoration of heads, interlace, foliage and animals is weathered but still pleasing. The window in its present form is clearly a rebuilding: the relieving arch of the earlier window is visible and the outer carved stones are the remains of the earlier label stops. Here and elsewhere it is clear how much the level outside the church has risen with burials. The main entry to the church for lay people was by a W. door, now gone (the present W. wall is largely modern). The small perforated disc-headed cross just inside is said to mark the grave of Julia McQuillan, 'the black nun',. Who was a recluse here in the mid-17th century. There are no windows in the N. wall (the cloister side), but in the S. wall is a door and there may have been four windows. The two more westerly openings are blocked, but the third is open and externally is decorated.
