BUILT HERITAGE AT RISK
Northern Ireland

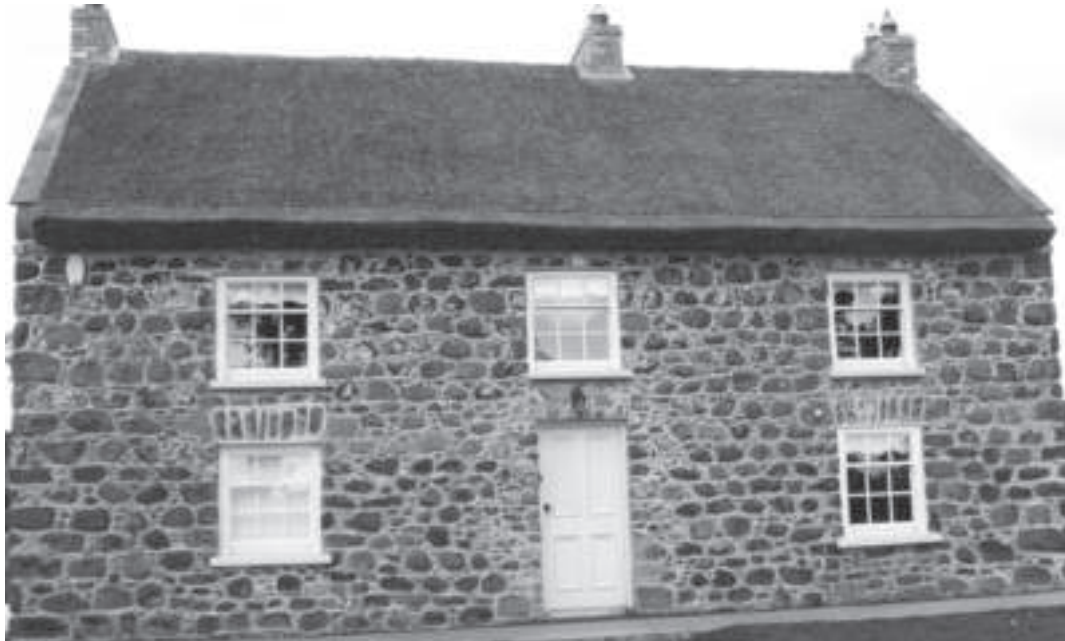
20 Scroggy Road,
Glenavy

The thatch on this two-storey dwelling had deteriorated quite rapidly in the 5 years prior to its re-habitation in 2008, allowing prolonged water penetration to the interior of the building. Its listing record suggests that it may have been partially raised by a storey in the late-19th century, due to the fact that prior to the renovation scheme only two-thirds of the roof structure was thatched; the remaining section being covered with slates. At that time this would have been a relatively common occurrence throughout the countryside – finances permitting.

Thanks to grant assistance from the Northern Ireland Environment Agency and the Northern Ireland Housing Executive under their Renovations Grants programme, the private owner has undertaken a comprehensive refurbishment. As a listed building a grant of 75 percent for re-thatching was available and the entirety of the roof is now covered with scallop thatch, laid by Gerry Agnew. Re-pointing was undertaken and the exposed stone cleaned, whilst landscaping has provided a more appropriate setting.

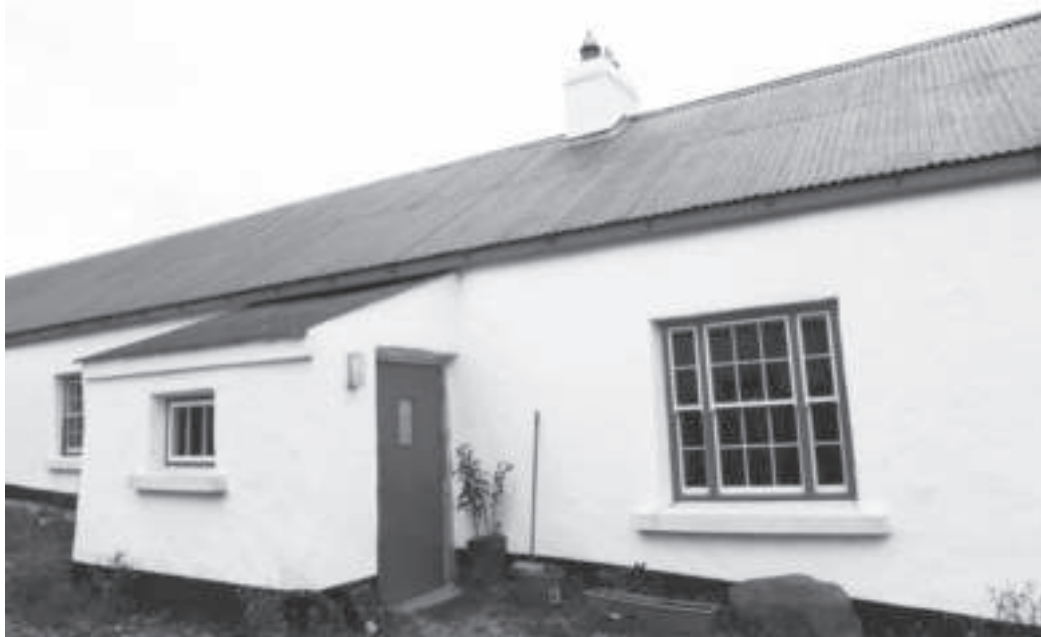
Robbs Ferry House,
Derrycarne Road,
Portadown

The future of this single-storey, mud-walled cottage with a corrugated iron-over-thatch roof, looked bleak at the turn of the millennium as it was then unlisted, and permission had been granted for its replacement. However, having languished on the online Built Heritage at Risk Register for several years, new owners came to its rescue in 2006, and they have since completed a sensitive domestic restoration using sympathetic materials and traditional techniques. Re-thatching of the structure is planned for a future phase of work, which will also include re-use of the range of outbuildings opposite across the cobbled yard.

Once home to the ferrymen who rowed locals across the River Bann, the cottage had been vacant for a number of years and had suffered both from vandalism and the effects of water ingress caused largely by previous inappropriate repairs and alterations. The rarity of such buildings, which were once so common in the local landscape, was recognised by Northern Ireland Environment Agency in 2002 when it was 'listed' grade B1. Whilst this ensured that it could not be demolished overnight, it was ultimately the tenacity and vision of the owner which ensured such a happy ending: an inspiration for the numerous other rural vernacular buildings that are currently going to waste.

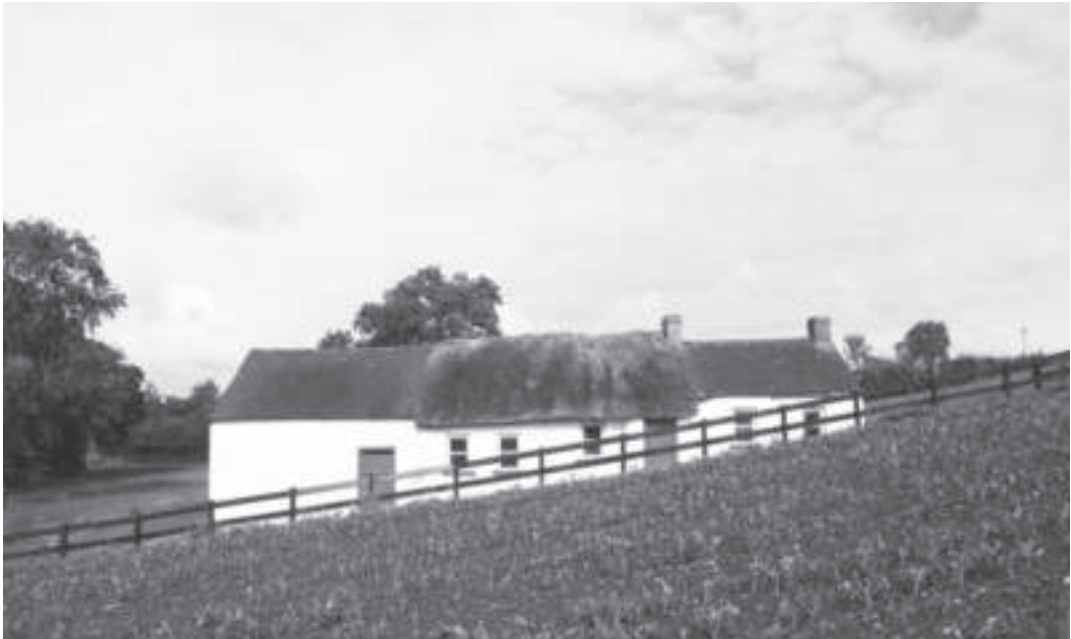
180 Mullalelish Road,
Derryhale
(before restoration)

In common with the cottage at Derrycarne Road, this mud-walled thatched building had fallen into a state of disrepair prior to new owners taking forward a scheme of repair. Said in its listing record to be of early-19th century origins, it is thought to possibly be older and a dating analysis using the roof timbers is to be undertaken. Tucked snugly into a gently rising hill in the heart of the County Armagh countryside, the unoccupied building featured in Buildings at Risk Catalogue, Volume 2 (p.27), when it was surrounded by agricultural buildings and shrubbery, all of which have since been removed.

The slated sections of the single-storey structure, the lower of which served as a barn, were in a reasonable state of repair, whilst the thatched roof had inevitably suffered greater deterioration, putting at risk the mud walls. With planning permission for conversion, the conservation project will involve the consolidation of the walls, re-thatching of the principal roof, the use of a limecrete floor and the construction of a modest new extension to the rear as a kitchen space, with the original being used as a parlour. The old barn will function as a sitting room whilst a mezzanine level will allow for additional living space. One ensuite bedroom and a bathroom will complete the internal accommodation. Another long-term building at risk should thankfully find an appropriate new use.

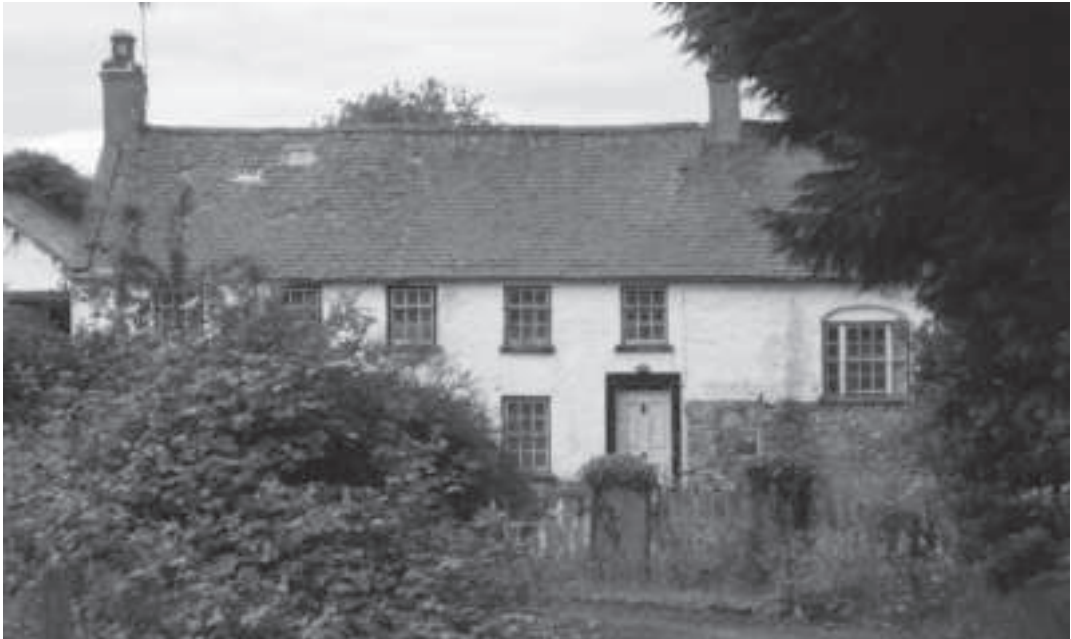
138 Gilford Road,
Breagh,
Portadown

A substantial, two-storey vernacular dwelling house with associated outbuildings, sited close to the edge of the suburban reaches of Portadown, just off the Gilford Road. The building appears to be in a relatively untouched state, free of unsympathetic modernisation, and retains its full Georgian glazing pattern as well as mostly original interior. It is unclear as to how long it has been uninhabited but the condition of the main dwelling house would suggest for at least a decade. The complex of buildings, together with a small agricultural holding, was recently sold.

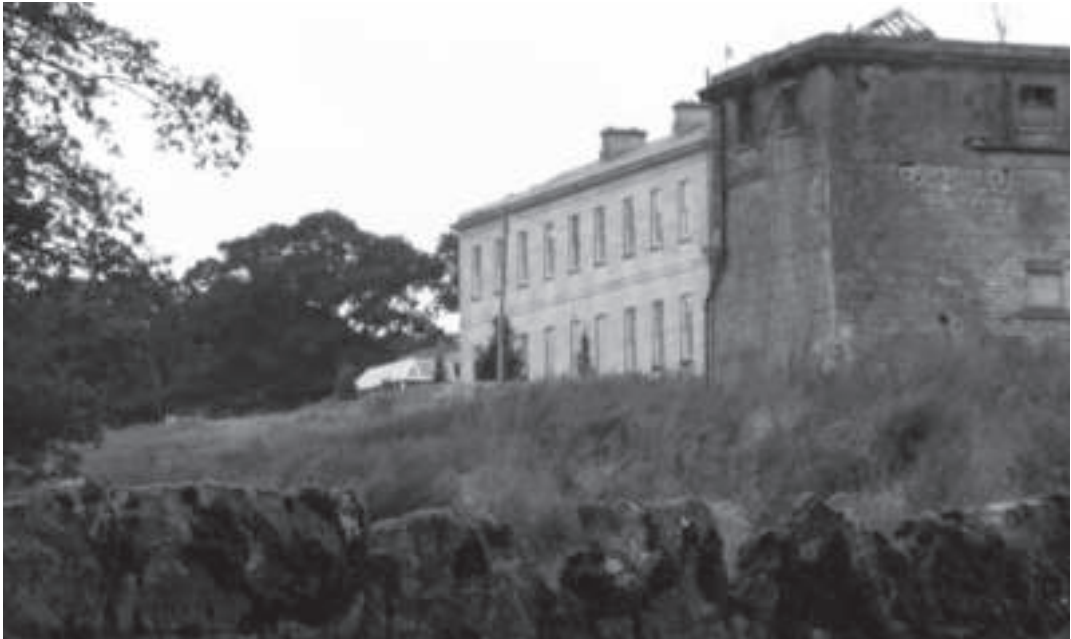
Castle Dillon House,
Turcarragh,
Armagh

An impressive and austere mid-19th century house, made up of a two-storey, nine-bay central section, with single-storey three-bay wings either side. It occupies an elevated position, overlooking a nearby lake, and is reached via a long and winding avenue, which it now shares with several newer dwellings. The present structure was built for Sir George Molyneux to the designs of William Murray, and it remained in the ownership of the family until 1926, after which it was used as a sanatorium, then a nursing home, but is now vacant and decaying. The rapidly deteriorating stable buildings close by featured in Buildings at Risk Catalogue, Volume 1 (p.50), Volume 4 (p.43) and Volume 7 (p.27) and are now minus their central louvred tower. The unlisted, heavily rusticated twin gate lodge (possibly by Sir William Chambers) also appeared in Buildings at Risk Catalogue, Volume 6 (p.40). The main house should not be allowed to deteriorate to such an extent and it is understood that conversion to residential use is under active contemplation.

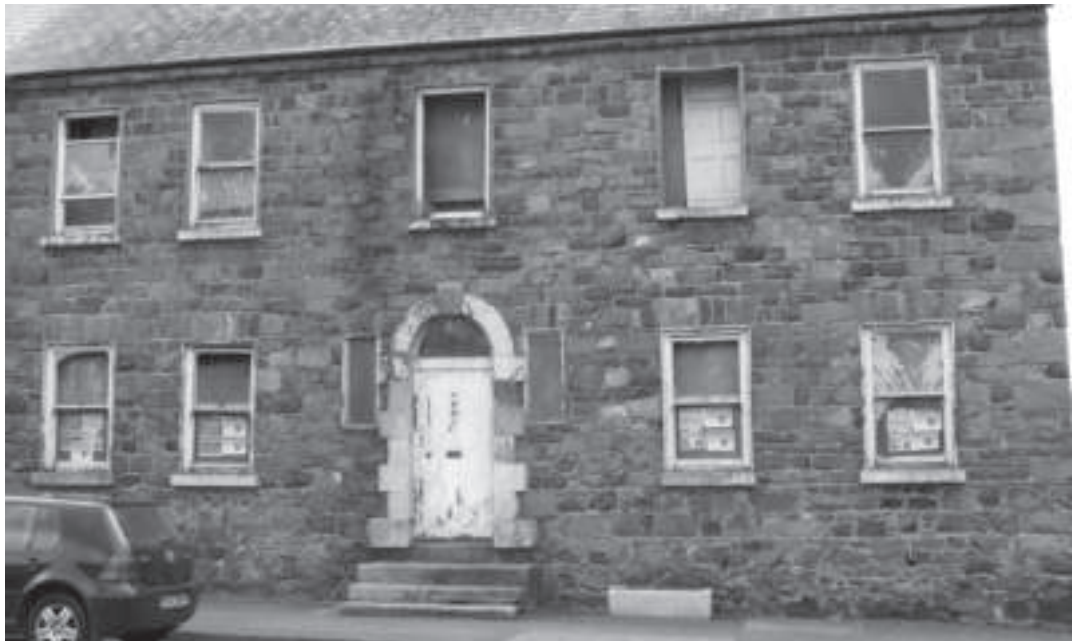
25 Main Street,
Markethill

A short distance from a terrace of three vacant listed buildings (54-58 Main Street) is this substantial stone built property in a more advanced state of disrepair. Described simply in its listing record as a “substantial two-storey terrace dwelling”, it is five-bays wide with a slated, pitched roof and a centrally placed dressed-stone door surround reached via four stone steps. The Gibbsian door surround is rather unusually flanked by two squat sidelights built into the wall at high level. It is now partially boarded up and several windows have been broken. The appearance of the main street would benefit greatly were it to be repaired.

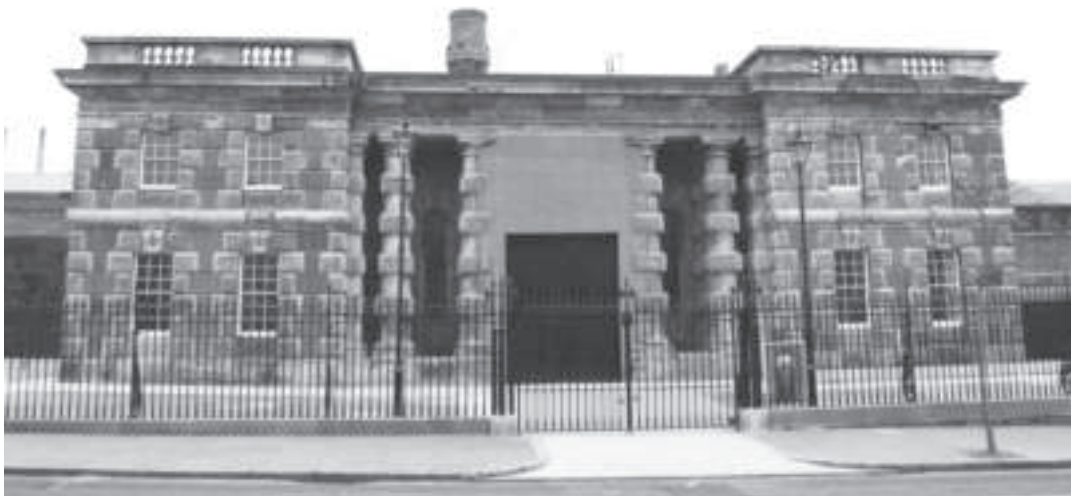
The complex re-use of the foreboding Crumlin Road Gaol in north Belfast is some way from completion, but it has nevertheless been included as a case study following the recent unveiling to the public of a partial restoration scheme, thanks to a £1 million investment by the Department for Social Development. The Gaol, and contemporaneous court house opposite, requires little introduction as both are well-known landmarks of significant historic and architectural interest. Designed by the prolific Charles Lanyon, in very contrasting architectural styles, the Gaol is built on an innovative radial cellular plan form based on Pentonville Prison in London but it is the first to have been built in Ireland using this system. Opening for prisoners in 1845, many alterations and changes have been made to the structure over the years, including the addition of a tunnel linking to the court house in 1850, but the essential layout and most notable interior features remain untouched, hence Grade A listed status.

The Gaol closed in 1996, and in 2003 ownership was transferred to the Office of the First and Deputy First Minister. The recent investment included work to remove unsightly security structures, restoration of the historic cast iron railings, repairs to damaged masonry, lighting improvements, hard and soft landscaping, and health and safety enhancements. These have facilitated managed public access and the site has proven particularly popular for visitors on European Heritage Open Days. The rather macabre surroundings have also played host to a successful production of *Macbeth* as part of the Belfast Festival at Queens.

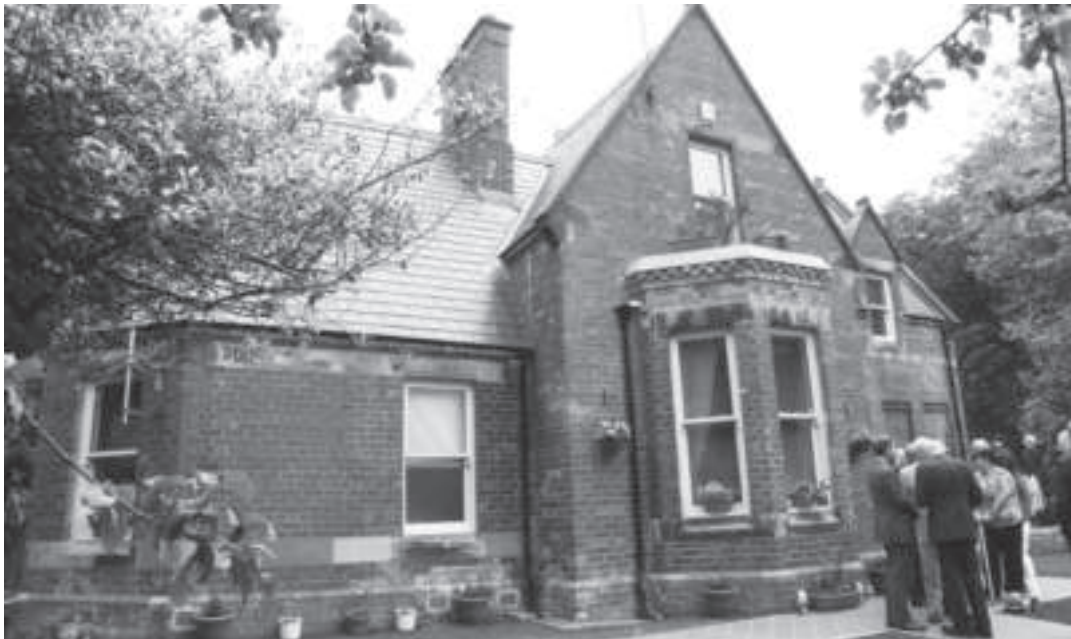
The unlisted Ormeau Park House was built in 1878 as the head gardener's cottage for Belfast's oldest municipal park, to the designs of the architect Timothy Hevey – who is perhaps better known for his work on ecclesiastical buildings in the city.

In a rather isolated position in the centre of the park, the house was extremely vulnerable to vandalism when it was vacated some twenty years ago, and has also suffered from the normal patterns of weathering and creeping decay. By the time that Hearth, a housing association specialising in restoring historic houses for social housing, had agreed a 50 year lease for the building with Belfast City Council, the building had lost most of its roof covering, an iron veranda had been stolen, it was covered in graffiti, and was smothered by rampant vegetation growth. The restoration of the house back to a single dwelling therefore presented numerous challenges, complicated further by the strong desire to apply eco technologies such as a heat pump for heating and domestic hot water needs, as well as less technologically advanced (but no less important) “green” solutions such as sheep wool insulation.

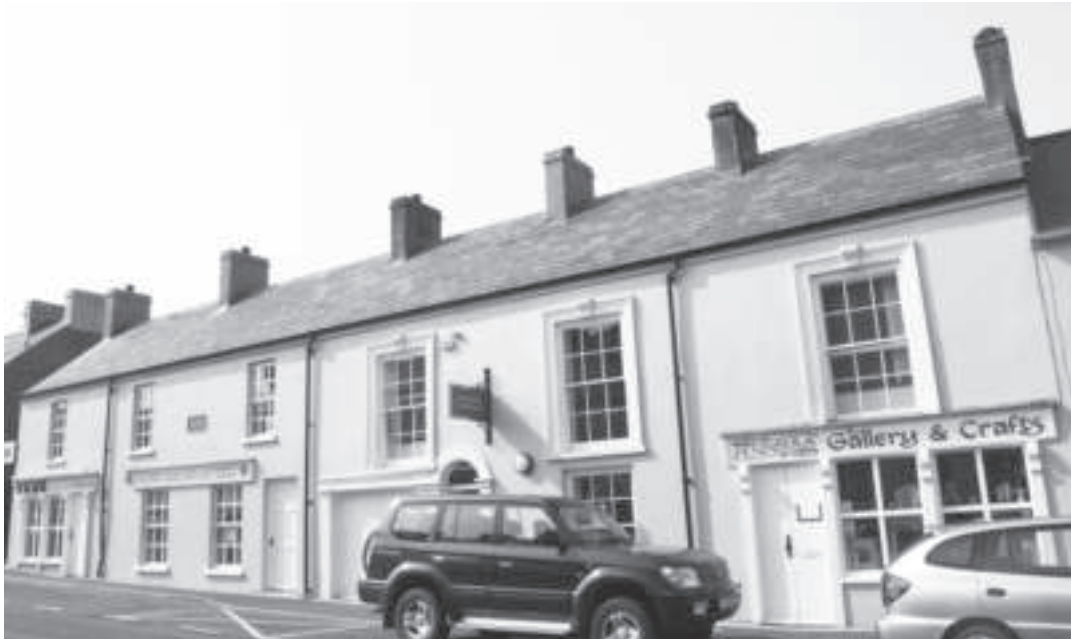
35-41 Main Street,
Kircubbin

The village of Kircubbin on the Ards Peninsula has not been ravaged by demolition and over-development to the same extent as many other rural settlements in Northern Ireland. As such, it retains a pleasant main street and has a number of fine terraced buildings, including the listed nos. 35-37 which have been brought back from dereliction as part of a wider development by Kircubbin Regeneration Programme Ltd., a local community based organisation.

The buildings form part of a mid-terrace grouping thought possibly to date from the late-18th century. They have, however, been subject to major alterations over the years, giving their front facades an informal and even quirky appearance. When they were featured in the last Buildings at Risk Catalogue (Volume 7, p.58), they were then empty and the site was for sale, with the ground floor and shop front boarded up.

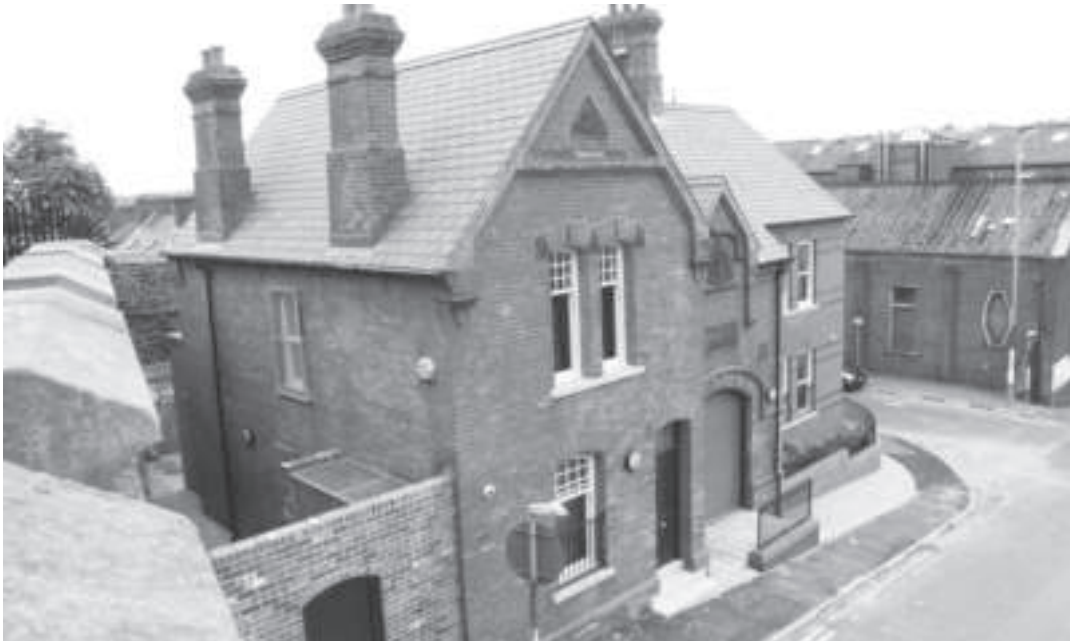
Former Fire Station,
Hawkin Street,
Derry

In the shadow of the famous city walls, next to the historic New Gate, is this compact and attractive red brick building, thought to be the earliest known fire station still to survive in Northern Ireland. Built in 1891, it somewhat ironically suffered extensive fire damage in 2006, a matter of months before a planned refurbishment scheme was due to start on site. By then the building had been vacated, having last been occupied as an office by a local community group, and with use as a fire station having ceased in the 1960s.

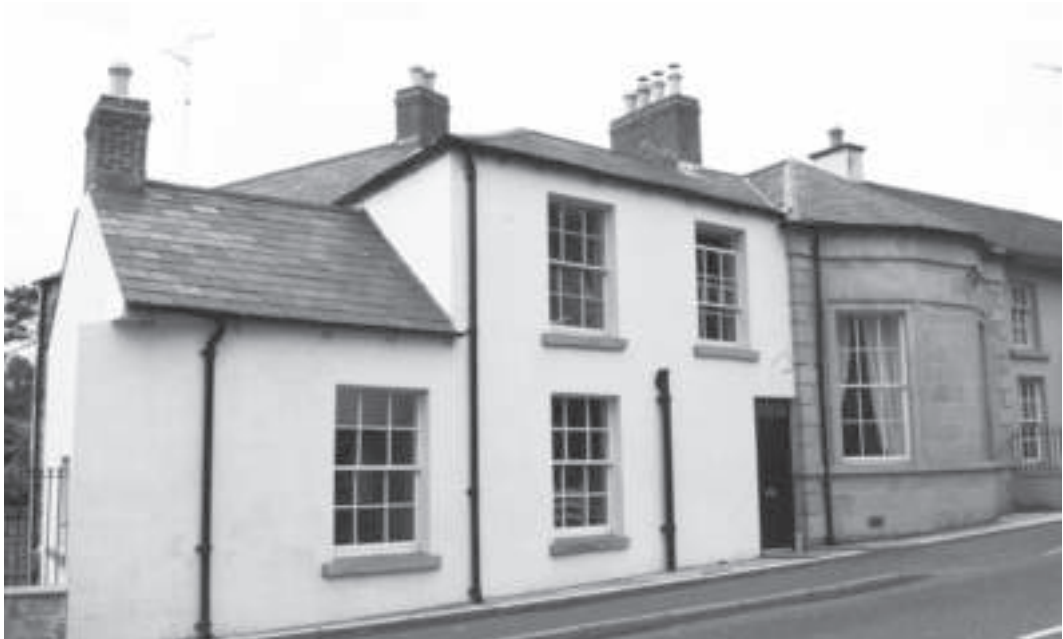
Laurel View Villa,
Main Street,
Donaghmore

Laurel View Villa is an important and intriguing historic building on the main street in Donaghmore, located in a prominent position close to the entrance to the village. It is thought to have been built as a Brewer's House for the now demolished McKenzies Brewery but was latterly in a very poor state of repair having been vacant for several decades.

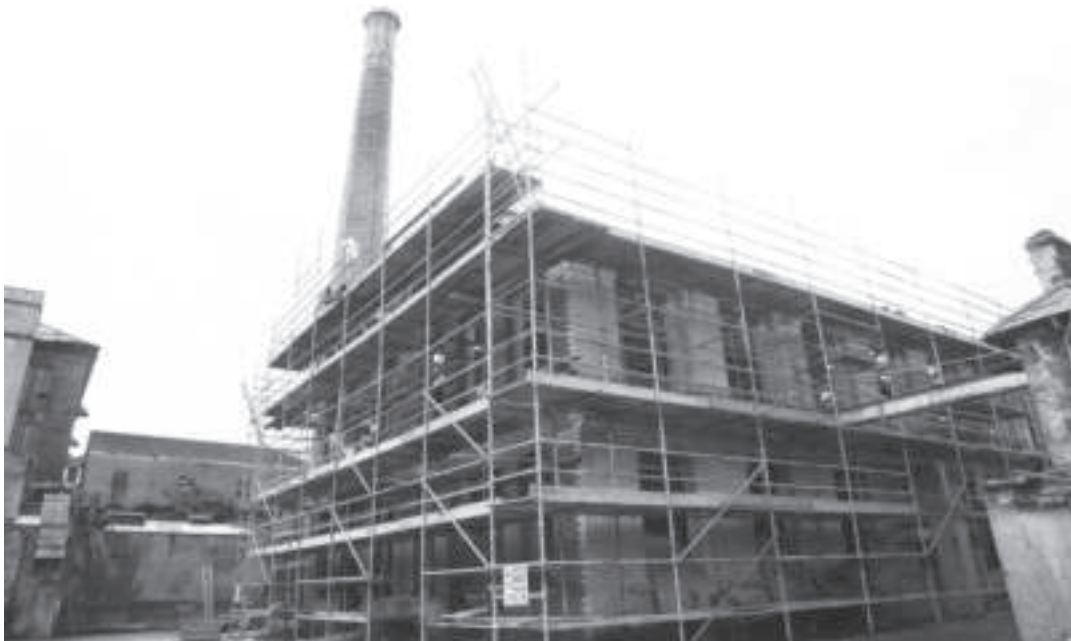
Herdmans Mills,
Sion Mills
(during restoration)

The Italianate Herdmans Mills requires little introduction as not only did it feature in the popular BBC Restoration series but it was also the final entry highlighted in the last Buildings at Risk Catalogue (Volume 7, p.107), where it was described as “An immense industrial complex whose importance to the nearby town of Sion Mills cannot be understated”. The main building on the site, designed by WH Lynn in the early-1850s, is a four-storey, sixteen-bay spinning mill with a six-storey tower at one end. This structure remains redundant but several ancillary buildings, including the old maintenance block and the carpentry and paint shops are currently being turned into commercial workspace units by Sion Mills Buildings Preservation Trust, with funding from the International Fund for Ireland; the Department for Social Development; the Department of Enterprise, Trade and Investment (EU funding); the Northern Ireland Environment Agency; The Clothworkers’ Foundation; Strabane District Council; and the Trust’s own resources.
